# NORTHRIDGE EARTHQUAKE ASSESSMENT REPORT

October, 1994

Report Number 1087

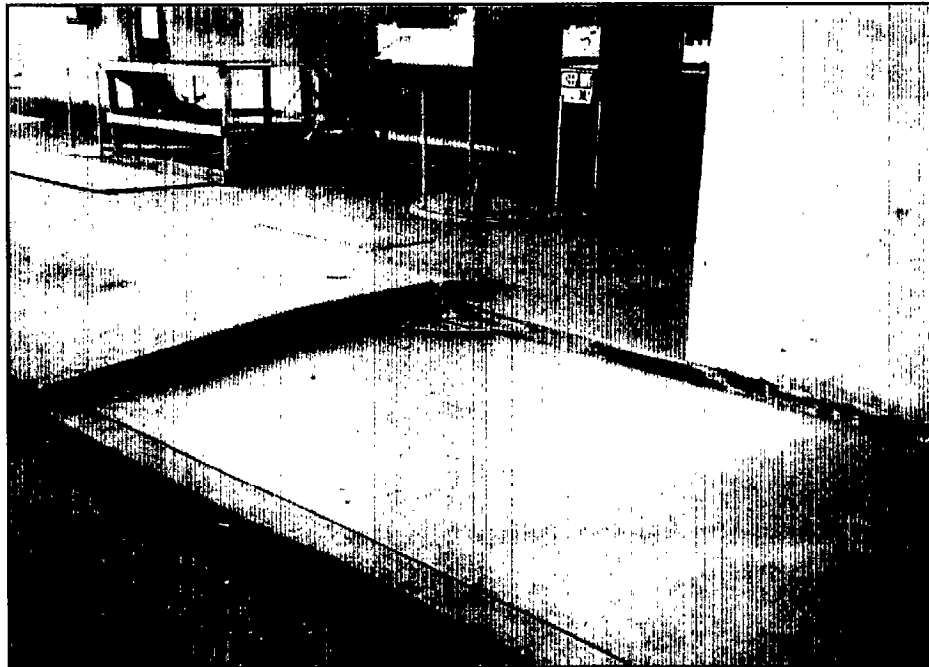
FIGURES 1 AND 2

Damaged Concrete

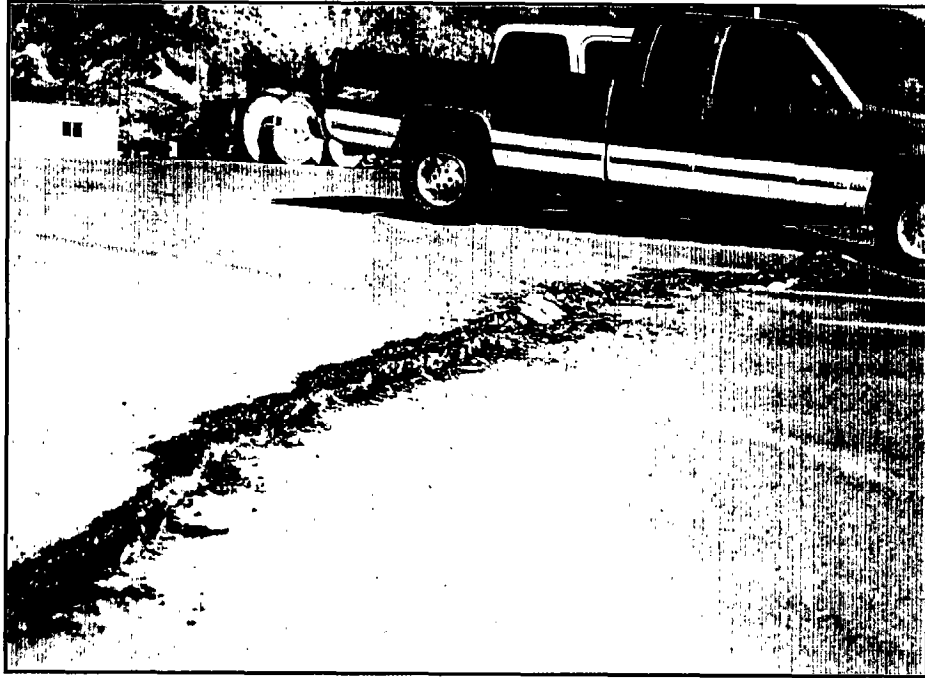
FIGURES 3 AND 4

Cracks and separation in asphalt

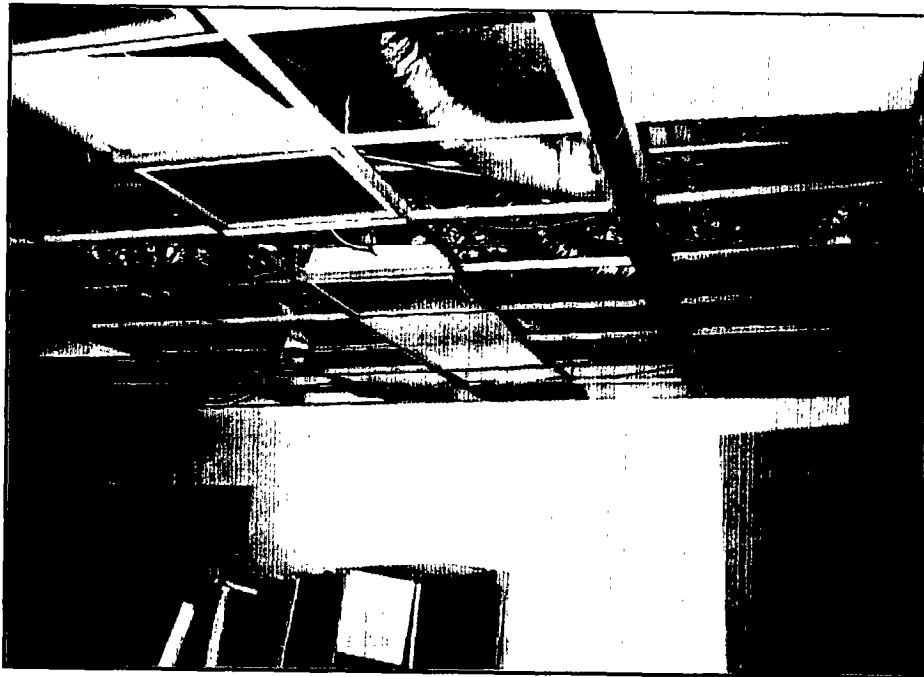
FIGURES 5 AND 6

Damage to Office Areas

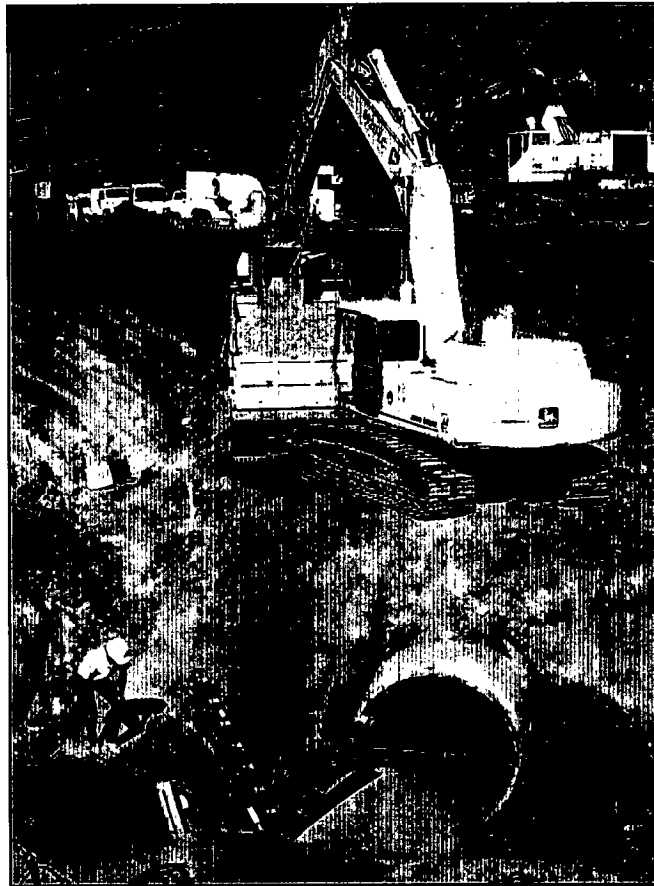
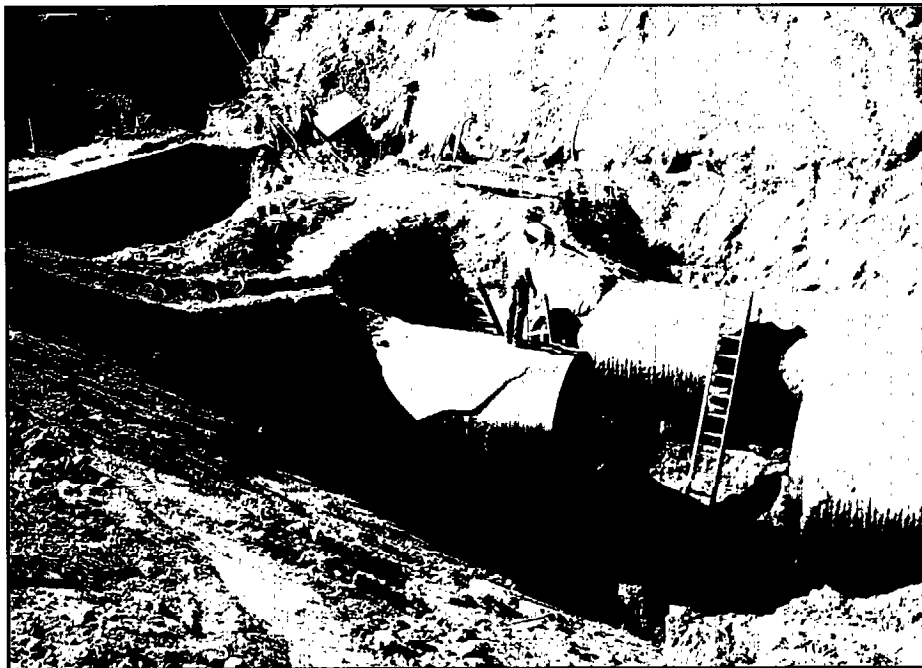
FIGURES 7 AND 8

Damaged section of 84-inch influent pipeline removed

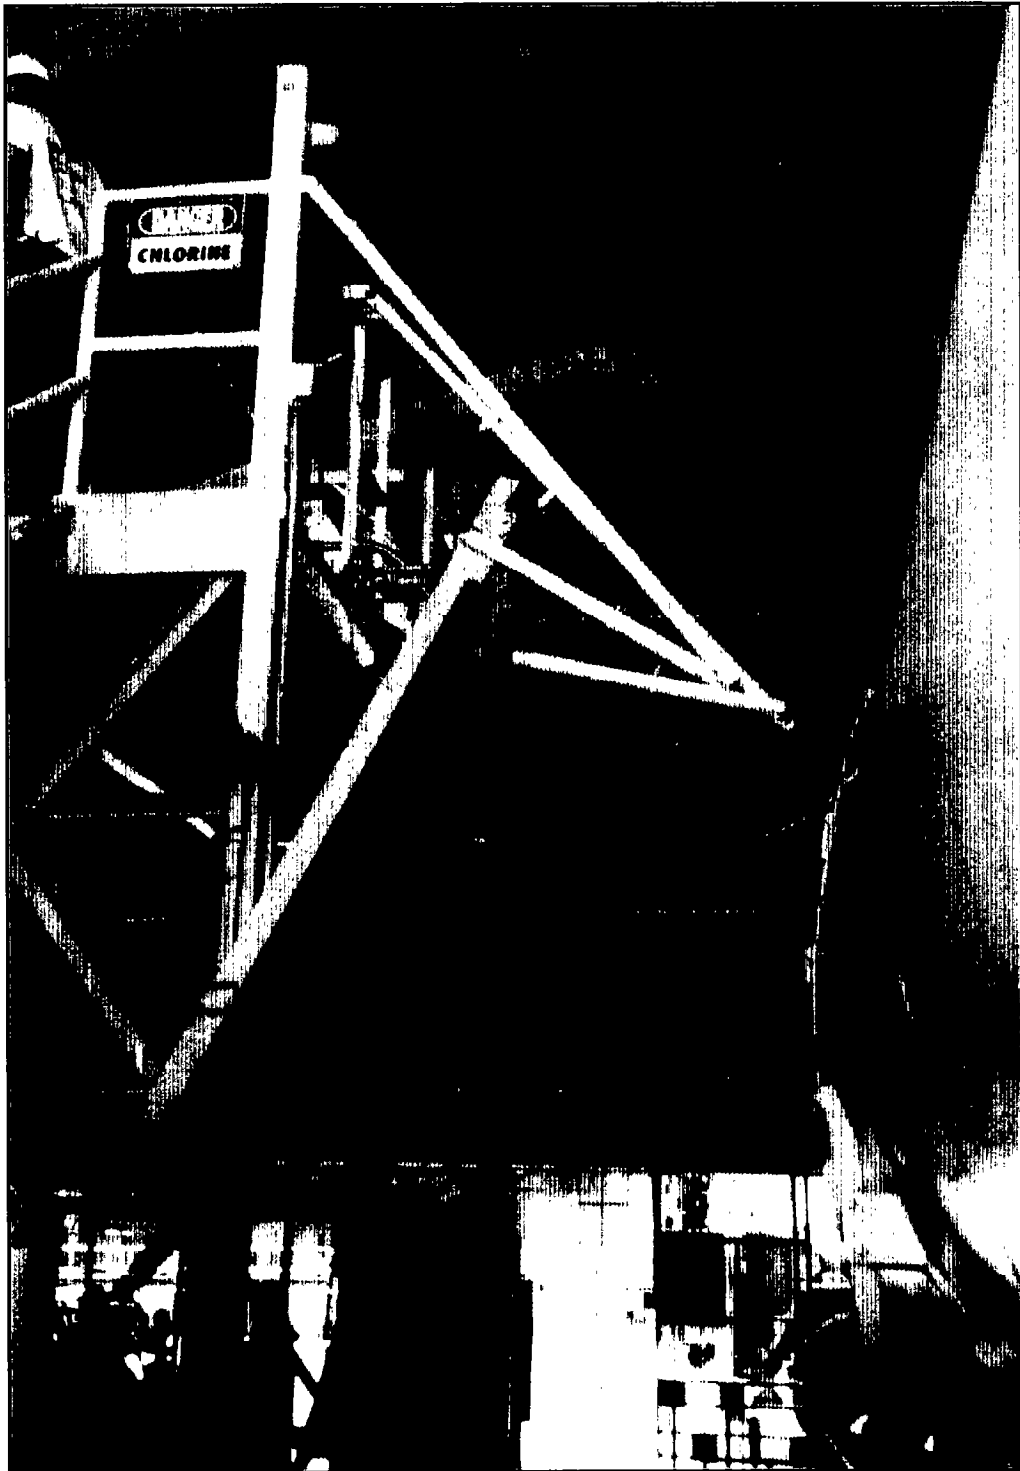
FIGURE 13

Damaged platform at chlorine railroad car

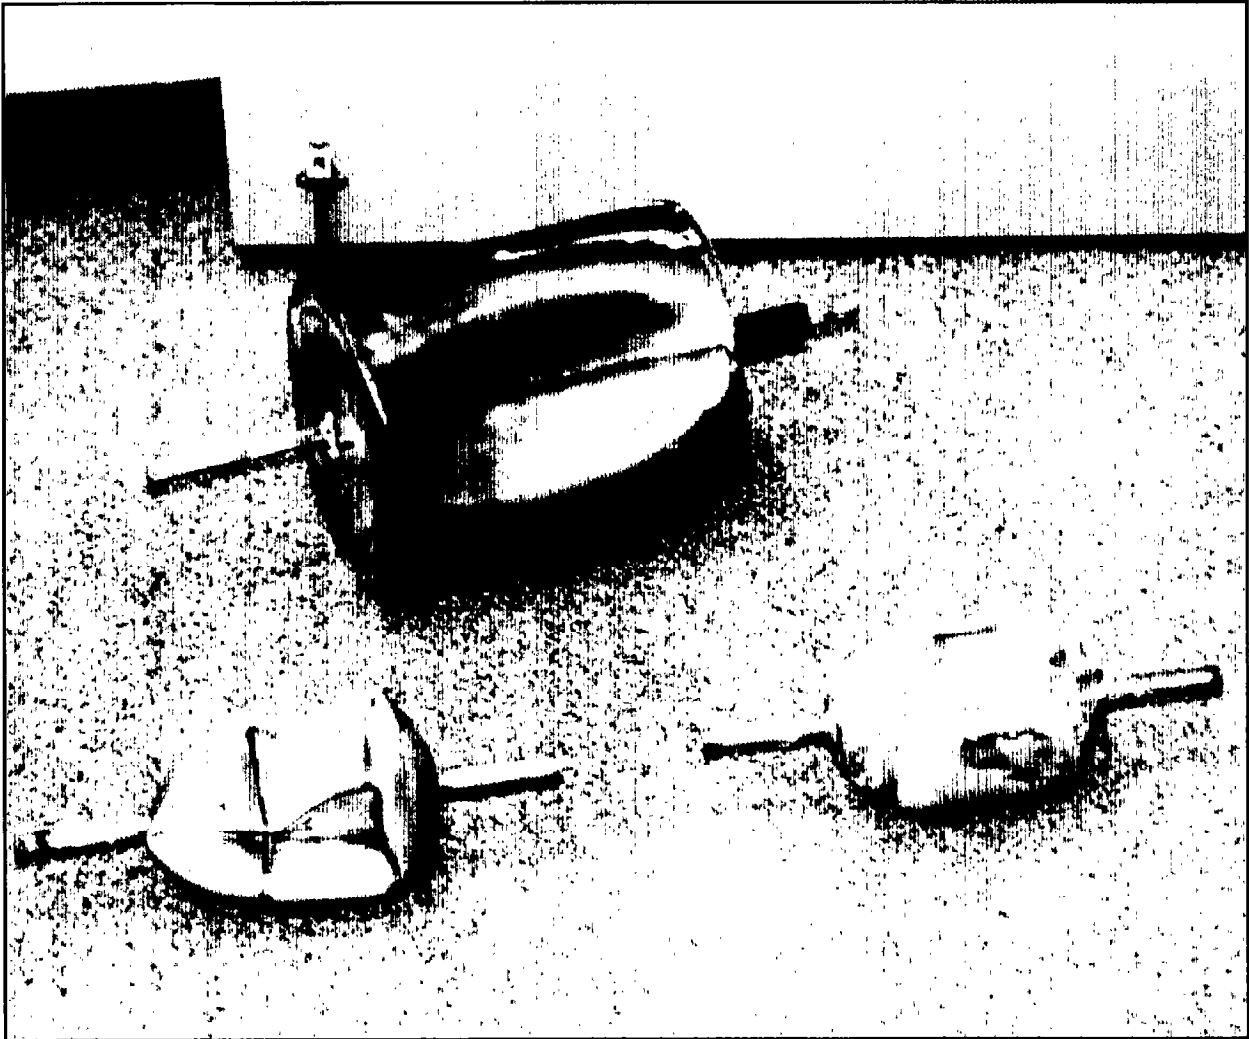
FIGURE 28

Damaged parts from air release and vacuum valves
