Update on Etiwanda Pipeline Lining Repairs

Engineering and Operations Committee
Item 6C
October 13, 2014

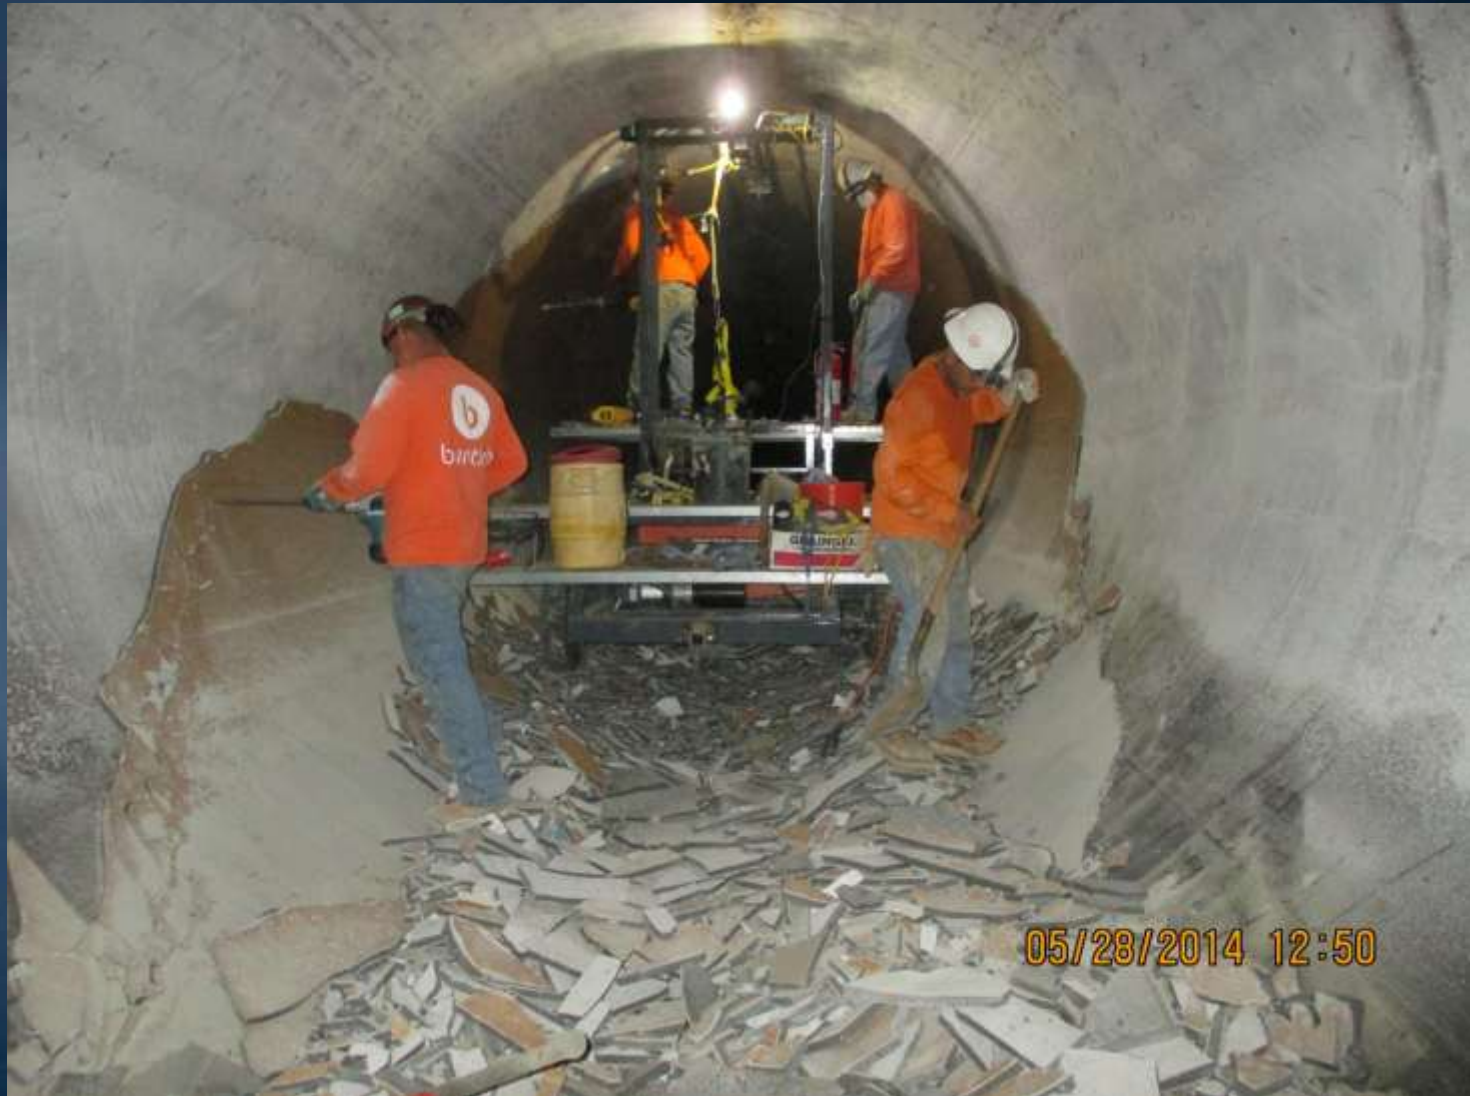
Etiwanda Pipeline

Removal of Mortar Lining

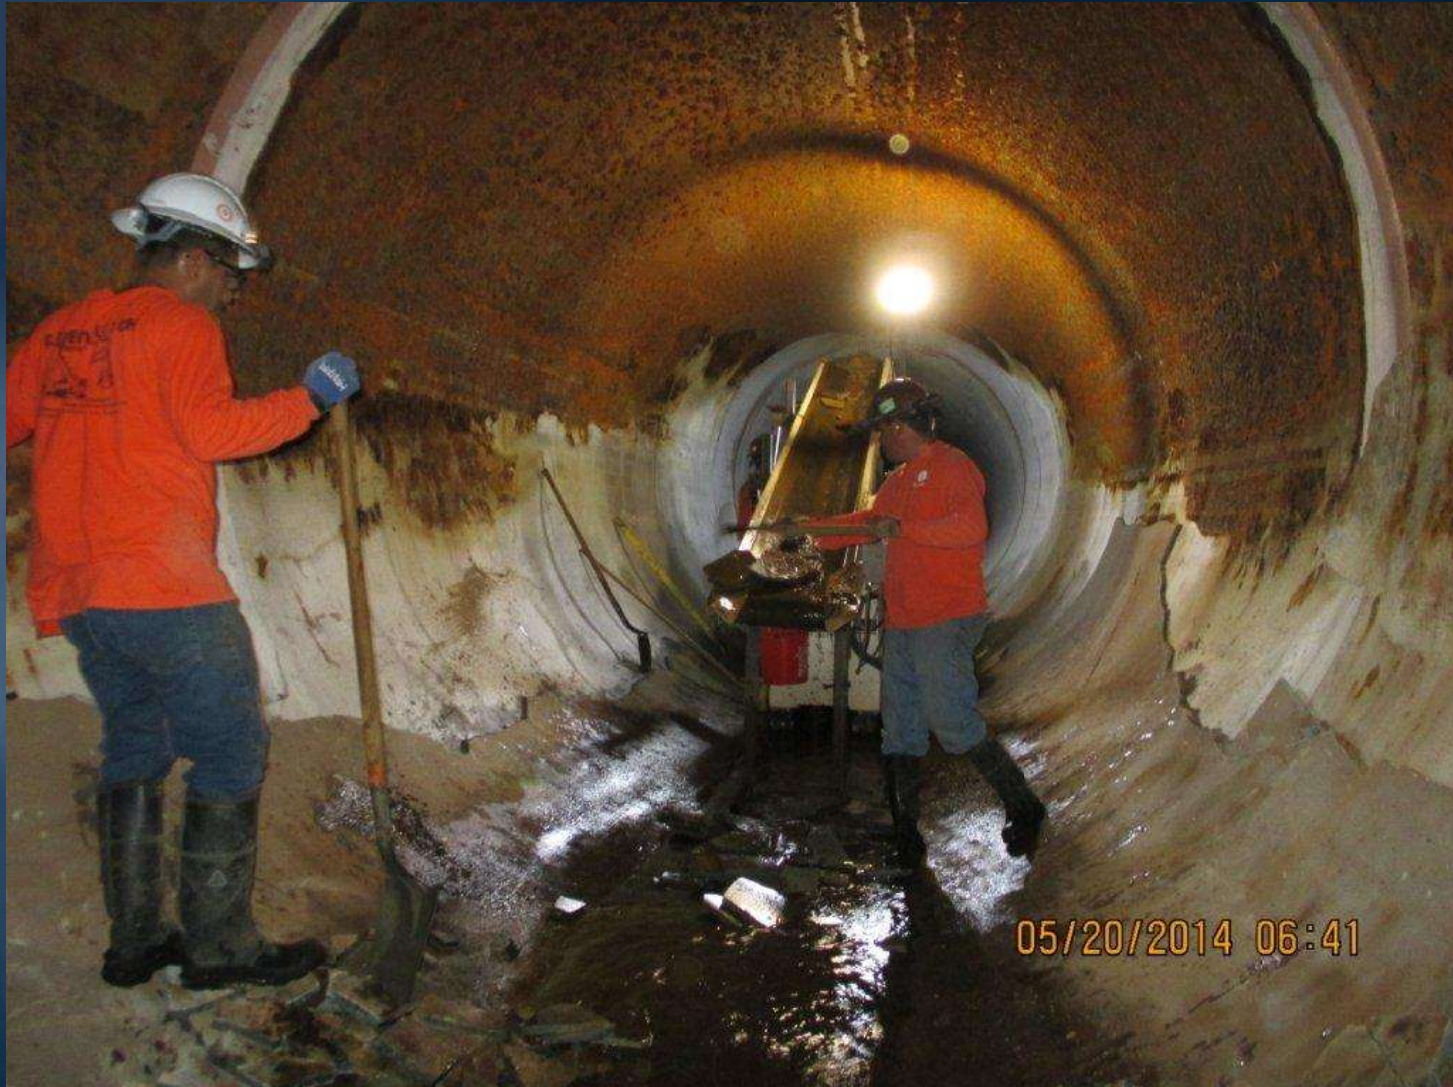
Etiwanda Pipeline

Before Blasting

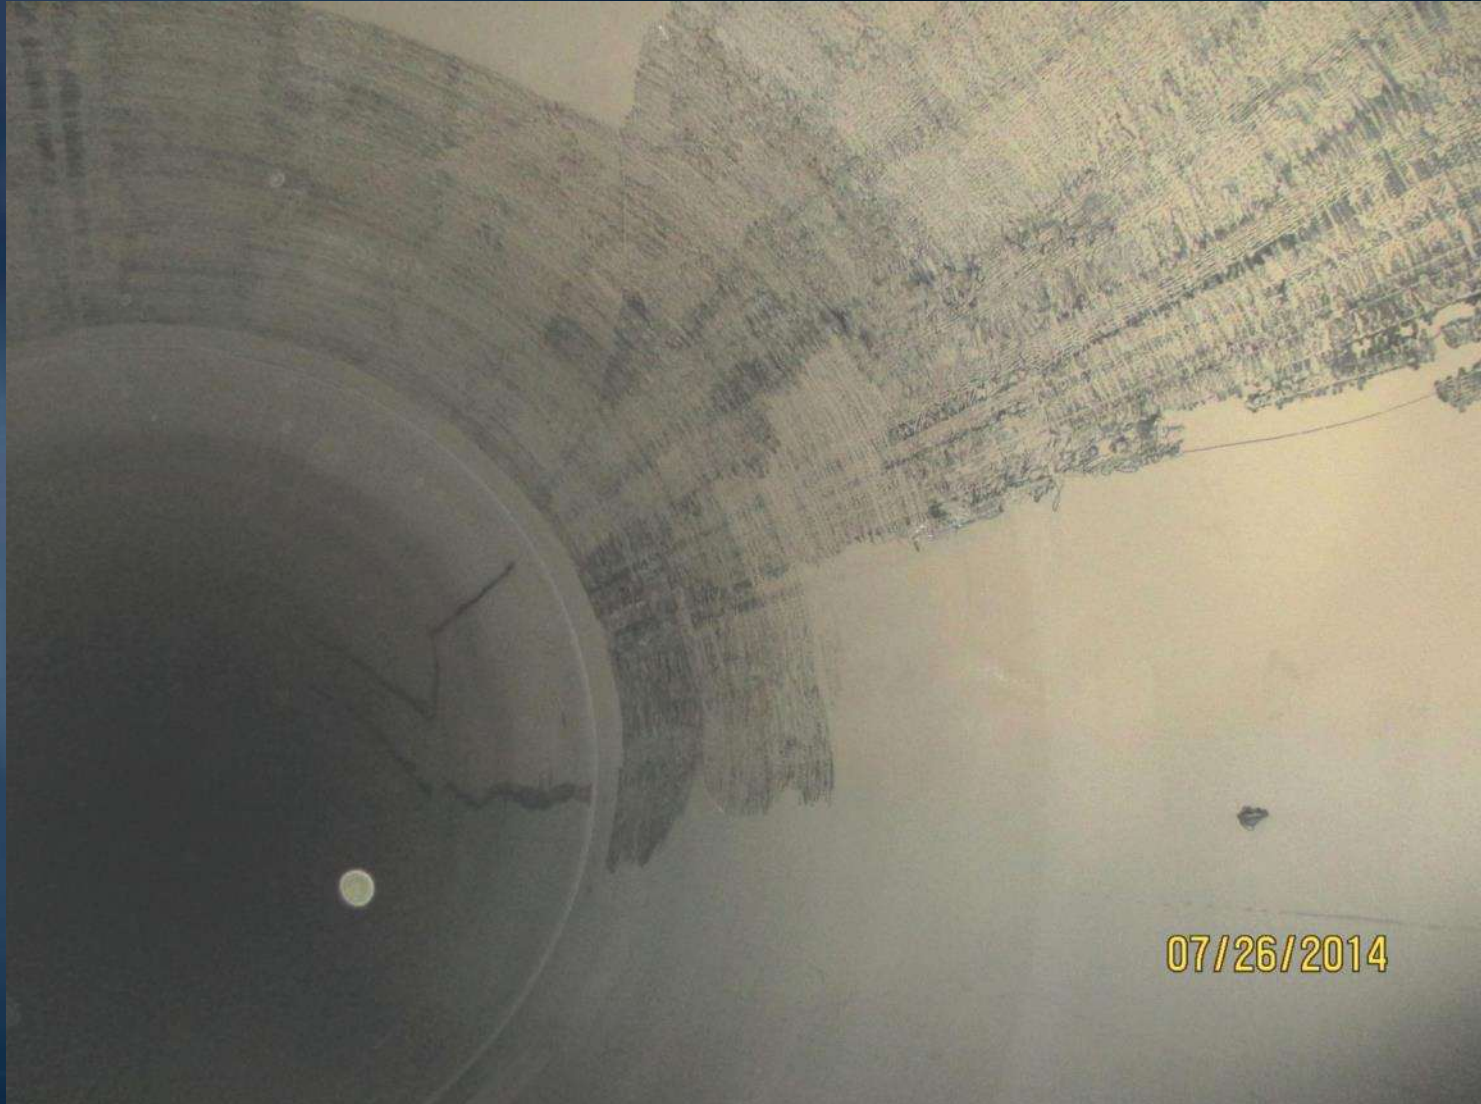
Etiwanda Pipeline After Blasting

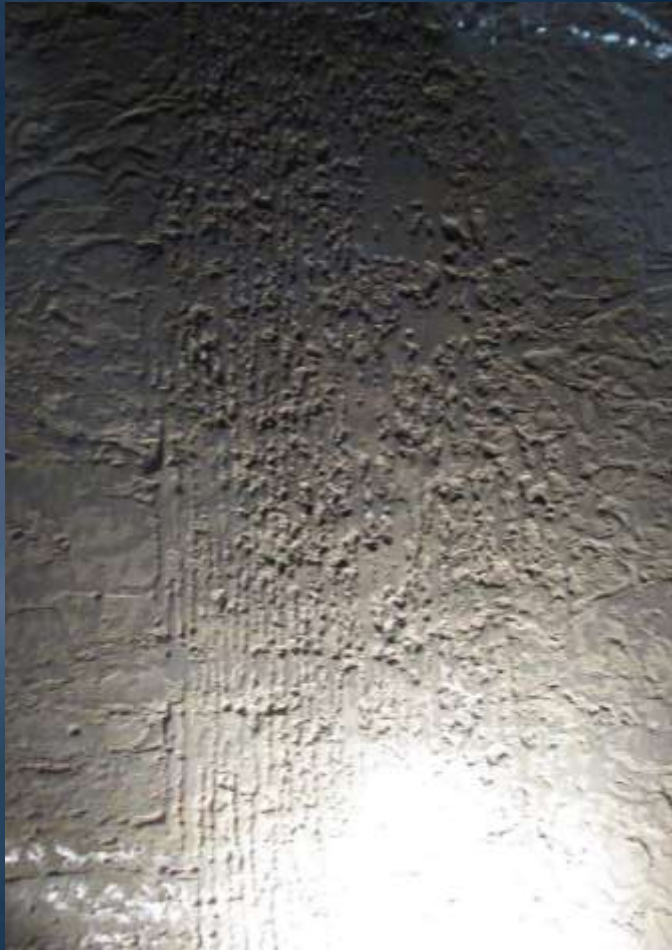
Etiwanda Pipeline

After Blasting

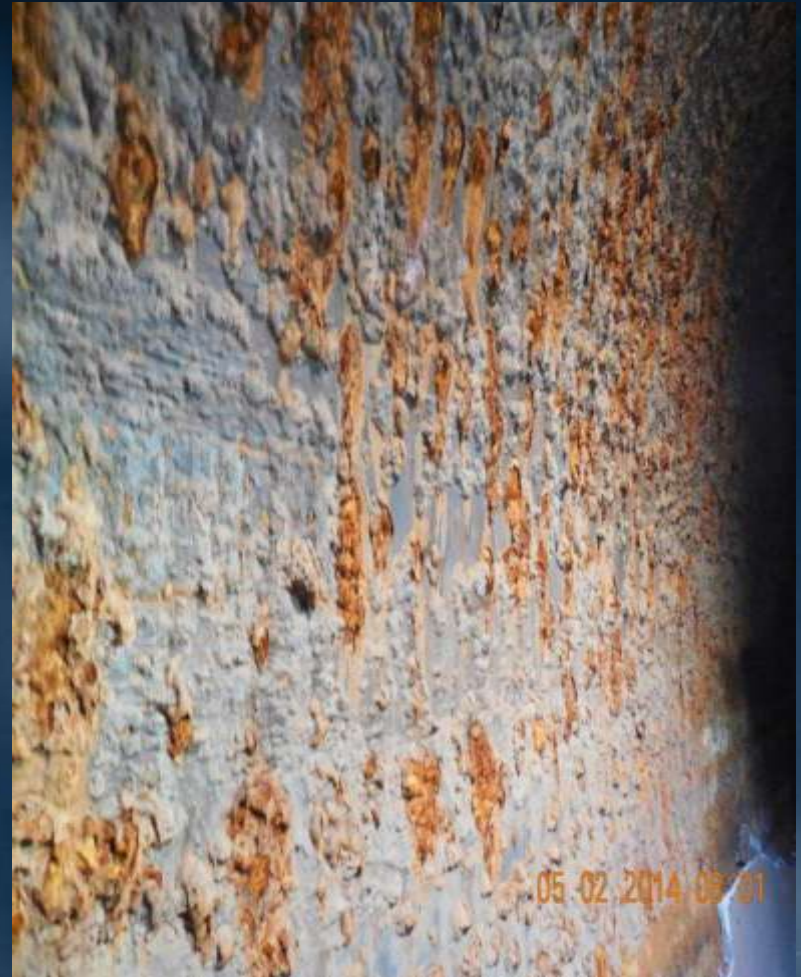
Before Blasting

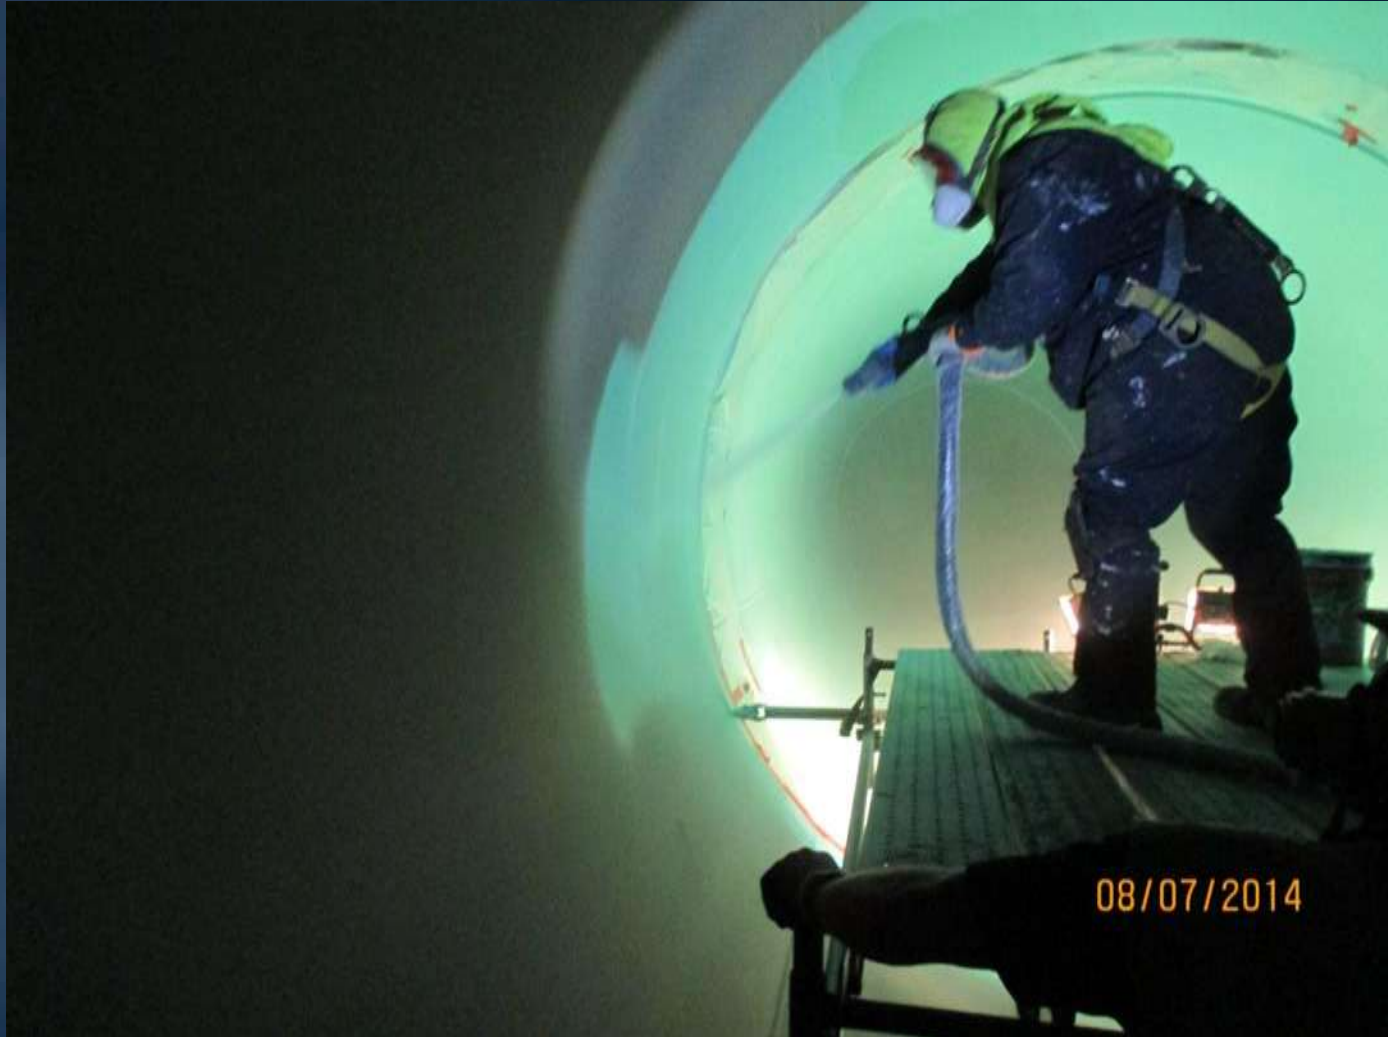
Etiwanda Pipeline Polyurethane Application

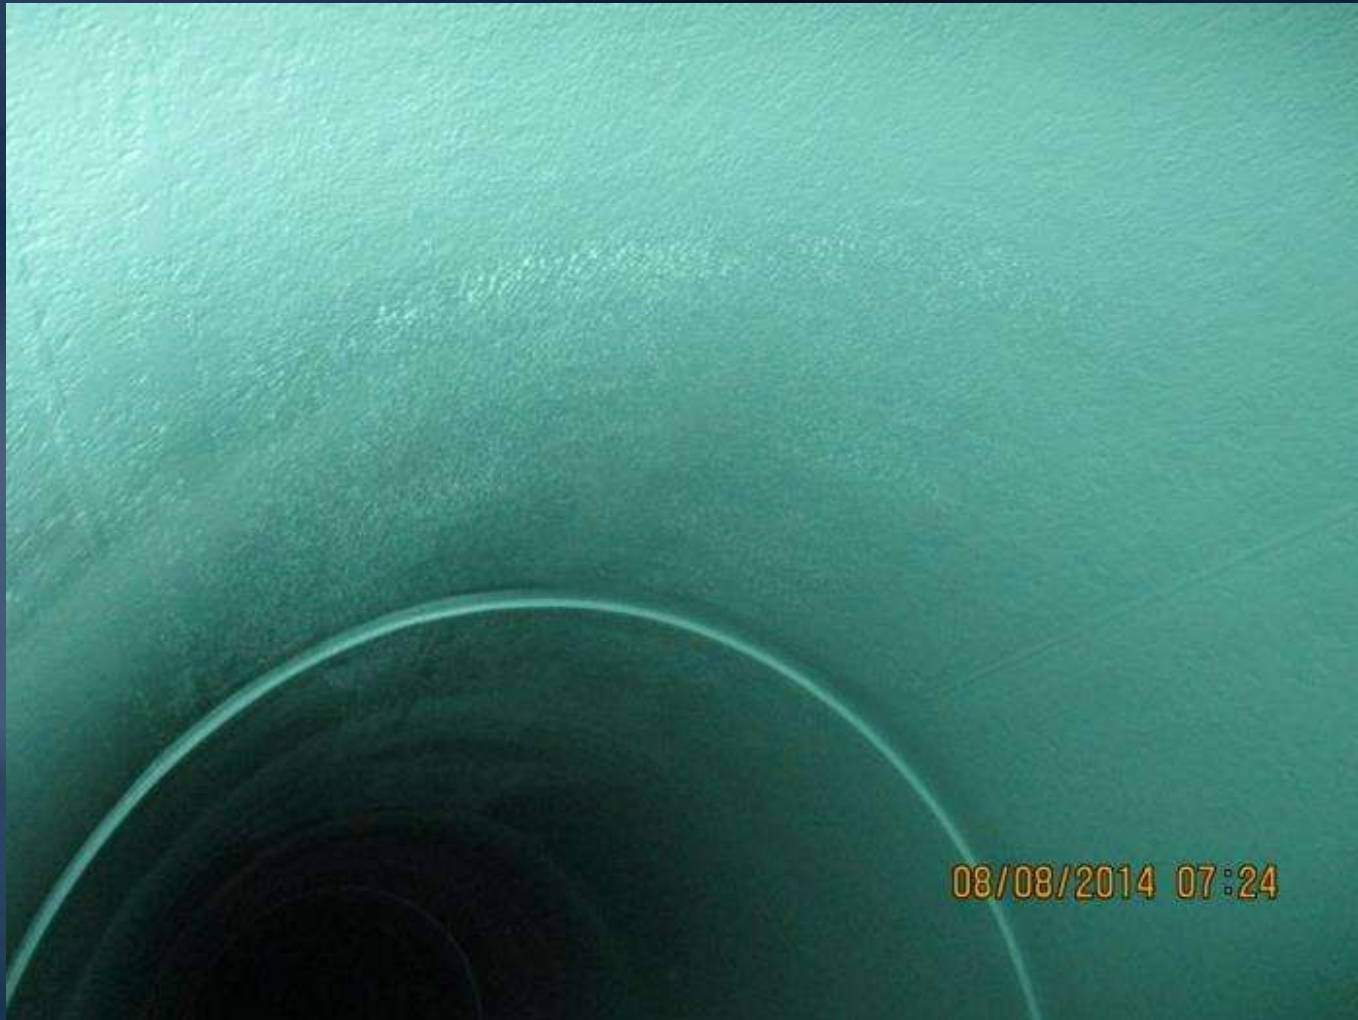
Etiwanda Pipeline After Coating
