# Authorize two improvement projects at the Diemer plant

Engineering and Capital Programs Committee

Item 7-4

August 17, 2009

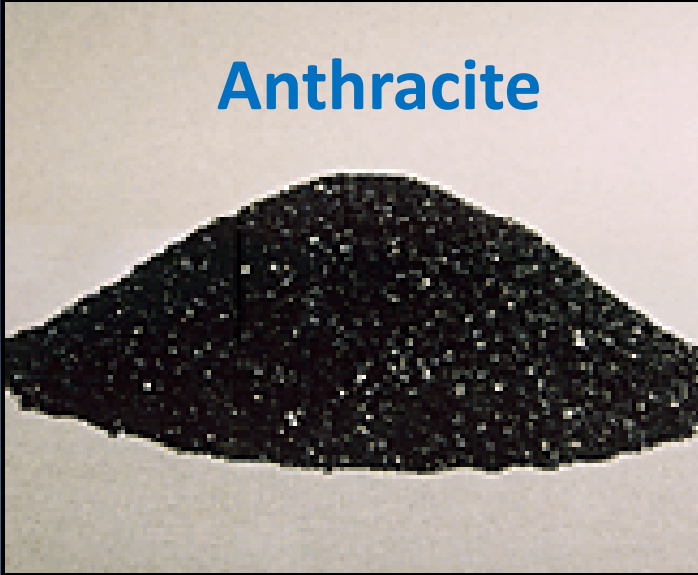
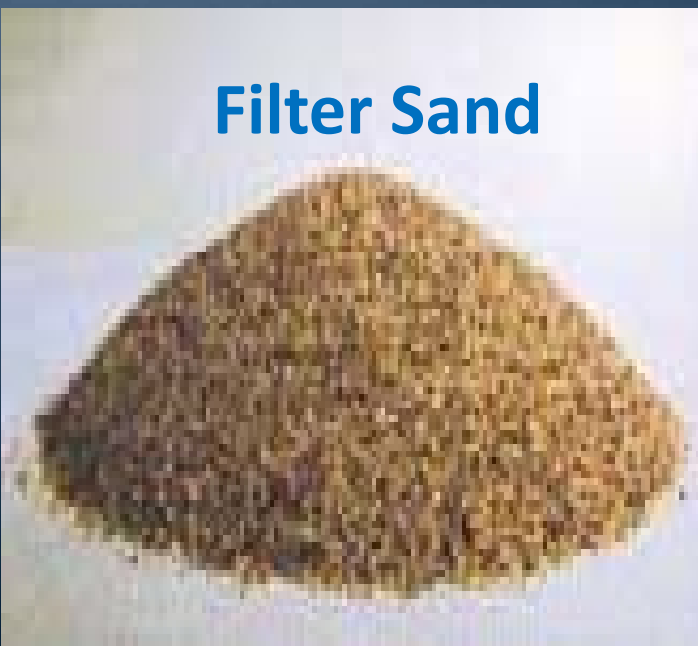
# Filter Media Replacement

- Background
  - Existing filter media is coated with manganese from previous ferric chloride use as coagulant
  - Biological filtration will commence after ORP is on-line
- Concerns/Issues
  - Release of high levels of manganese is expected, which will elevate color and turbidity
  - Potential complaints from member agencies and consumers

- **Scope**
  - Replace 14 in. of anthracite in the 24 east side filters
  - Replace 20 in. of anthracite in the 24 west side filters
  - Replace 8 in. of sand in all 48 filters
  - 7,200 cu. yd. total volume
- **Final Design**
  - Metropolitan Staff

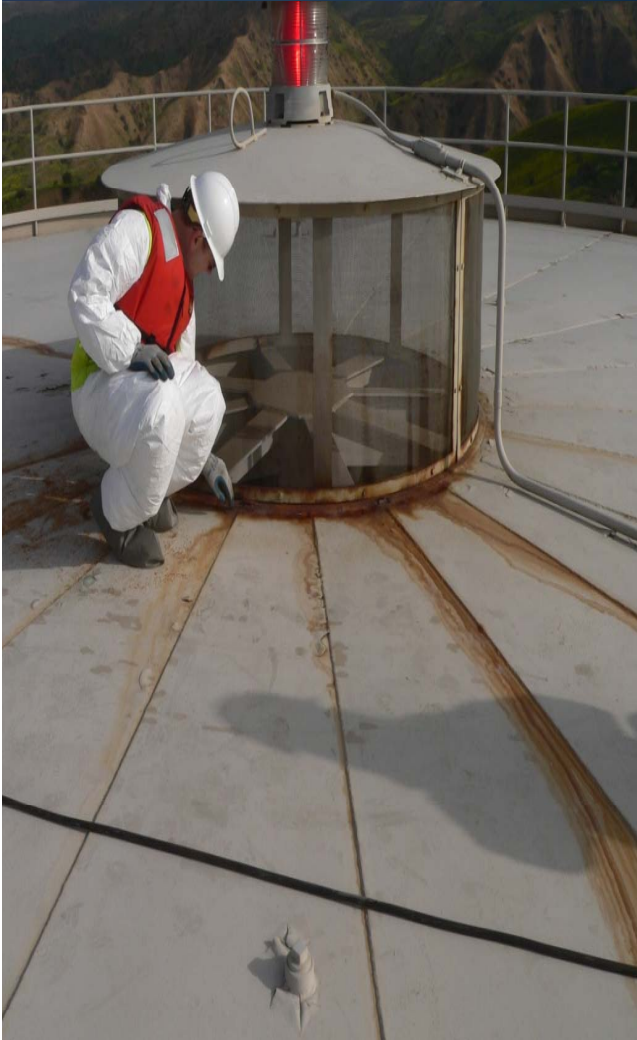
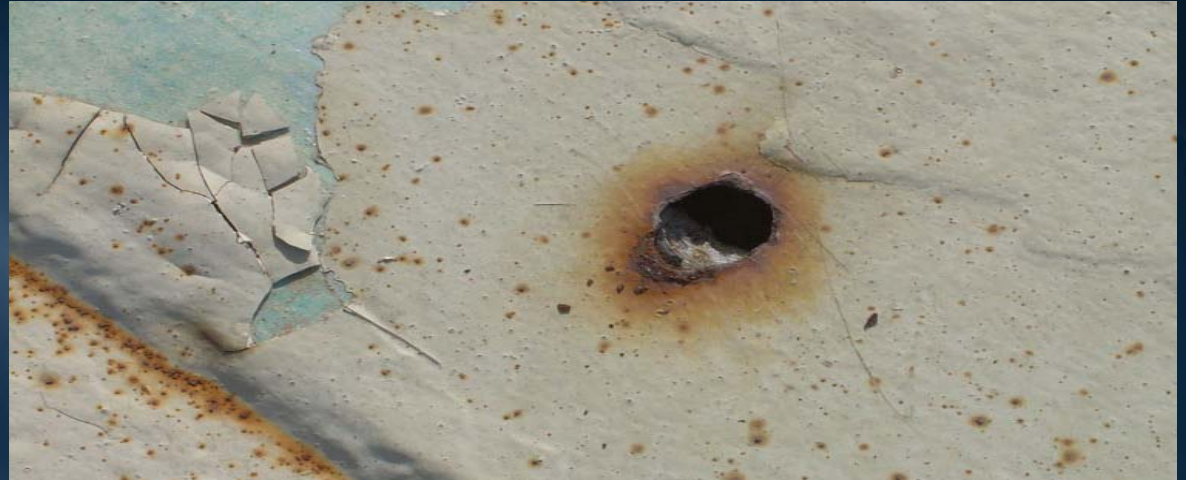
# 2008/09 Tank Inspection Findings

- 3/8-inch dia. hole in roof
- Significantly reduced roof-plate thickness
- Accelerated corrosion in interior roof support elements
- Local coating failures, exposing bare metal
- Interior lining below water surface in good condition

- Install additional openings in tank roof to improve ventilation
- Repair or replace corroded structural elements
- Repair local coating failures

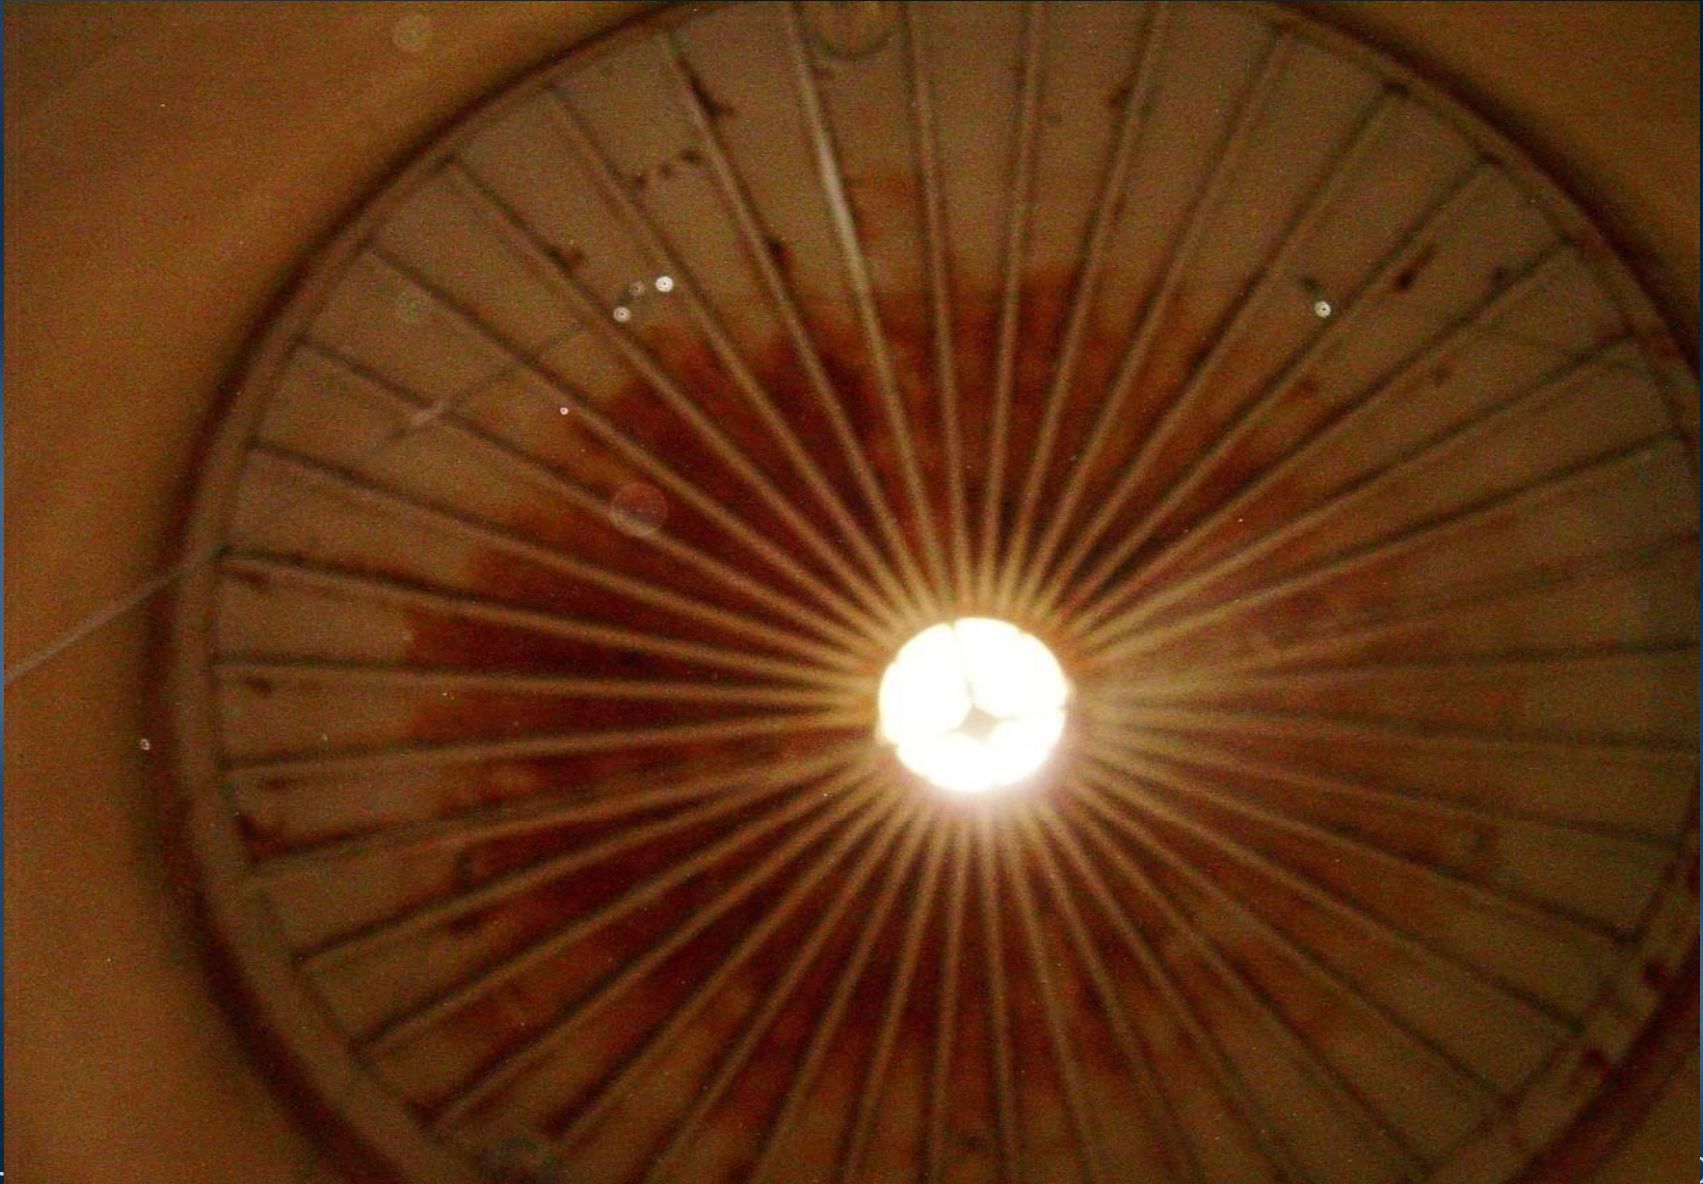
# Tank Roof Corrosion and Coating Failures

- Coating failures and corroded structural supports in tank roof
- Trapped chlorine vapor in tank's headspace zone, creating a highly corrosive environment
