Lake Oroville Spillway Update

Engineering and Operations Committee

September 11, 2017

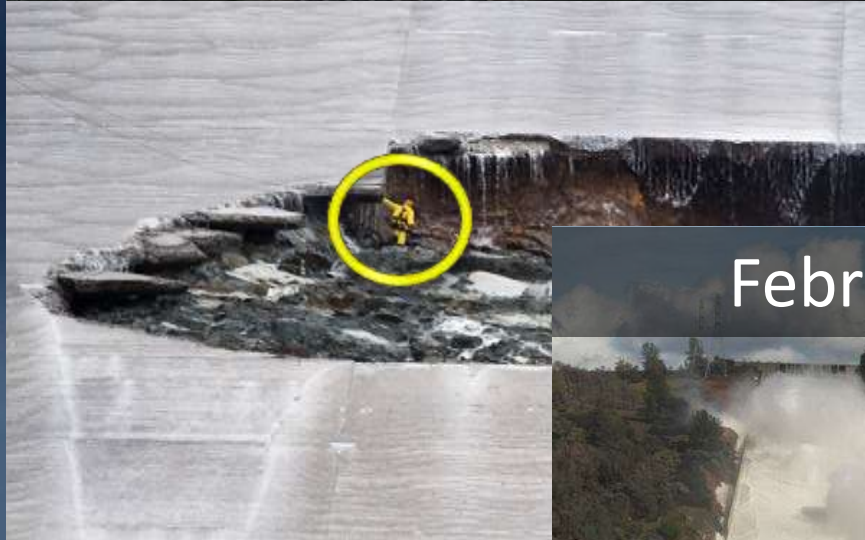
February 7, 2017

Oroville Spillway Incident

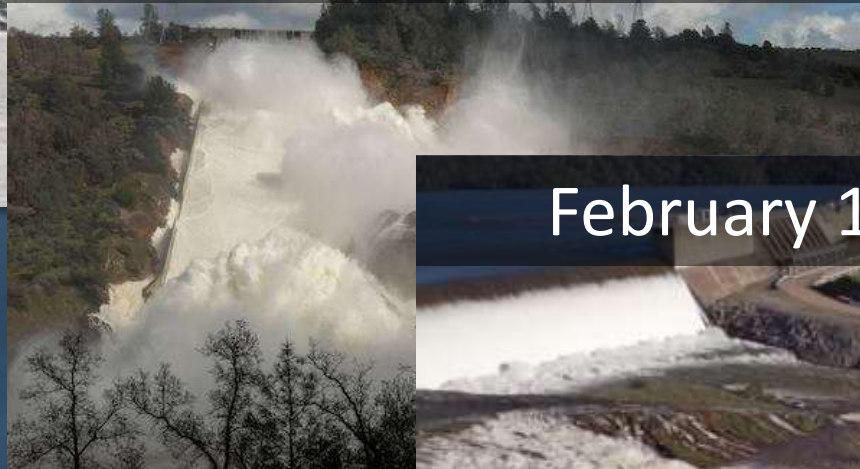
February 9, 2017

Deck and Foundation Erosion

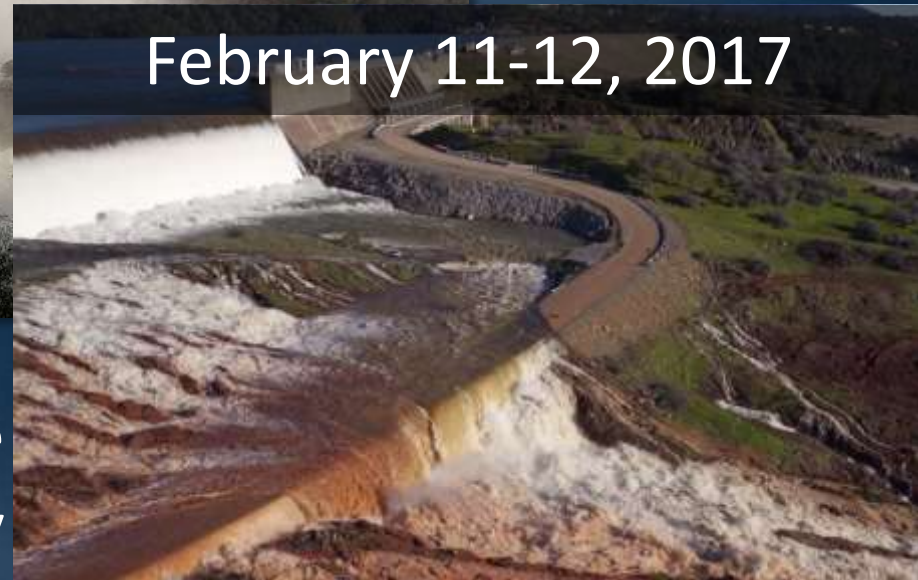
February 11-12, 2017

Inflows to Lake
Oroville reach
nearly 200,000 cfs

Flows over the
Emergency Spillway

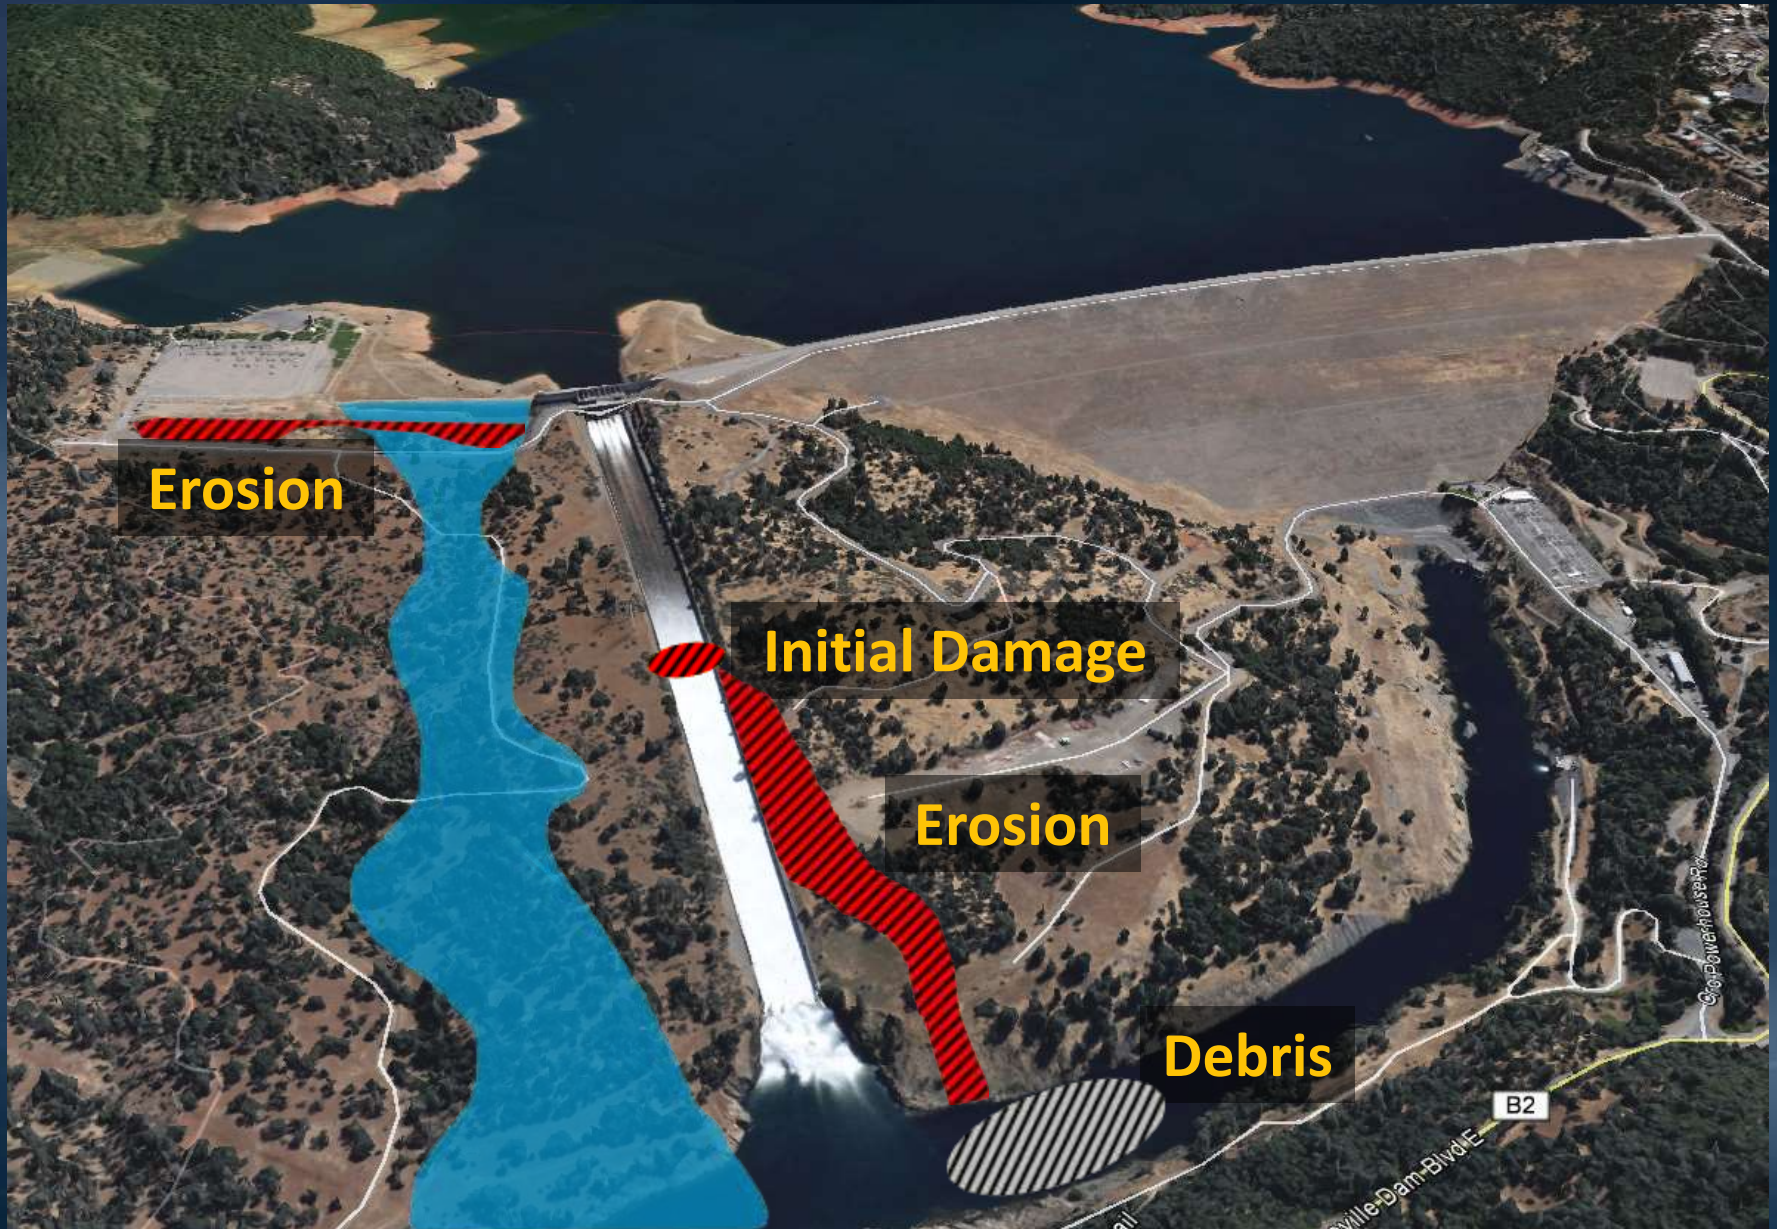
Overview of the Damage

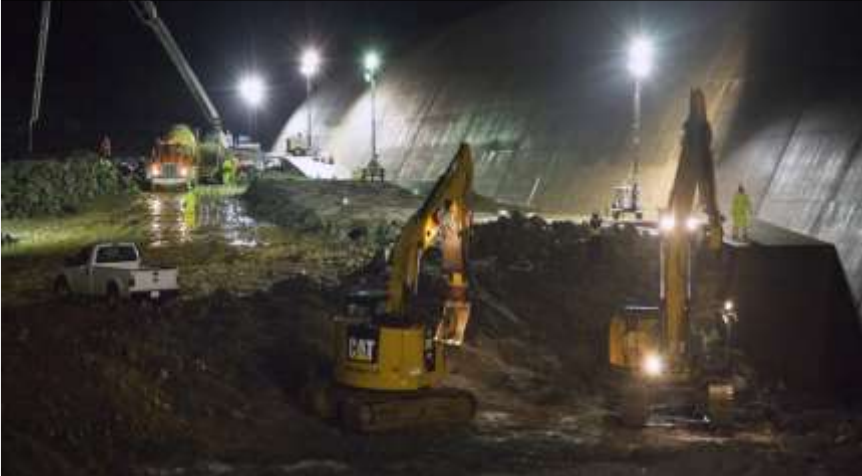
Erosion Protection

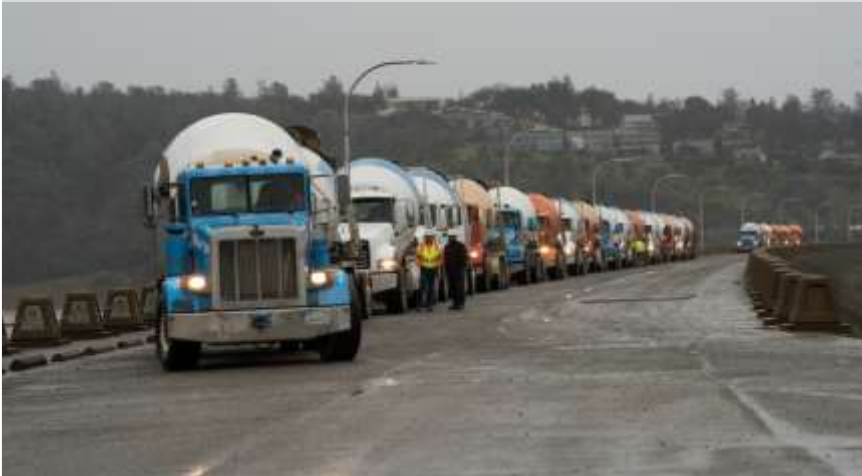
Concrete Repair Work

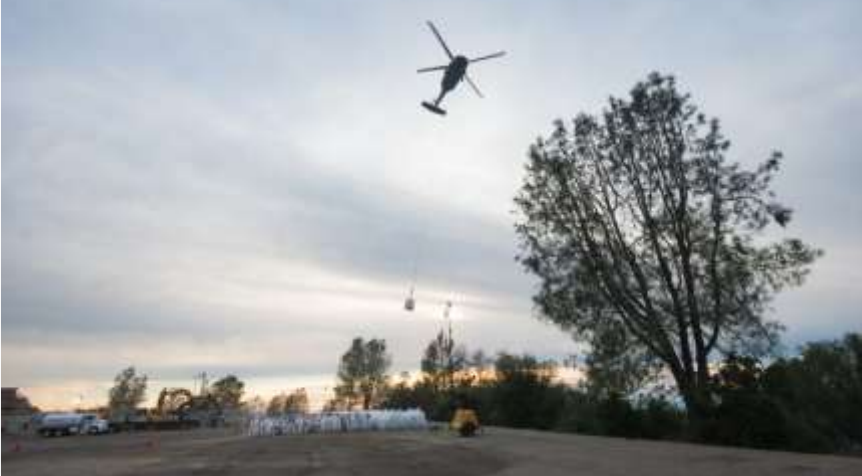
Rock Bag Reinforcement

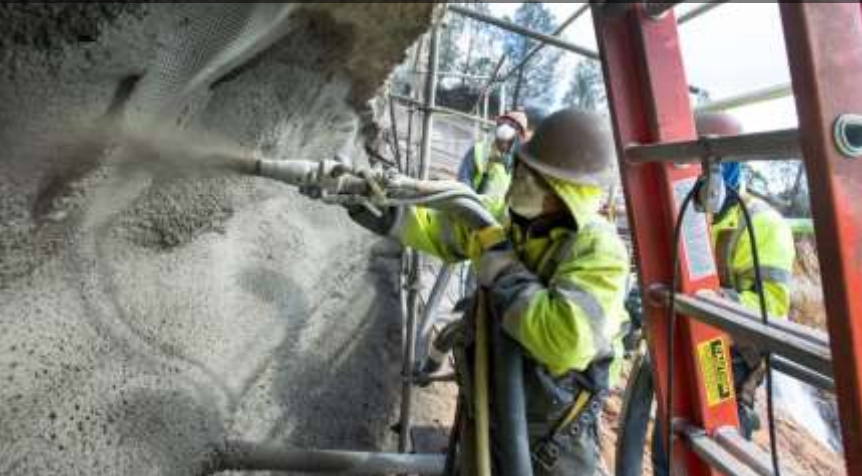
Patching, Inspecting, Studies

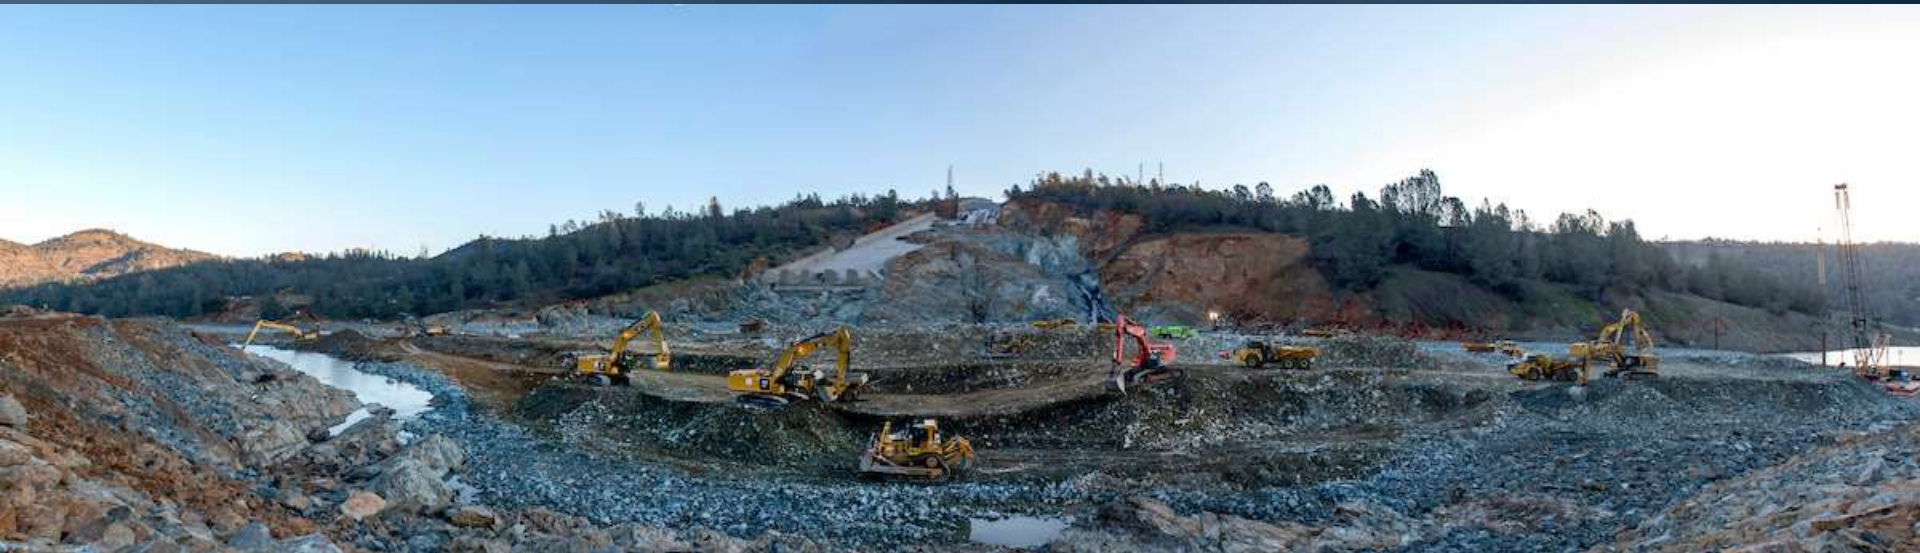
**Debris Removed from
the Thermalito
Diversion Pool**

Total of 1.9 million cubic
yards

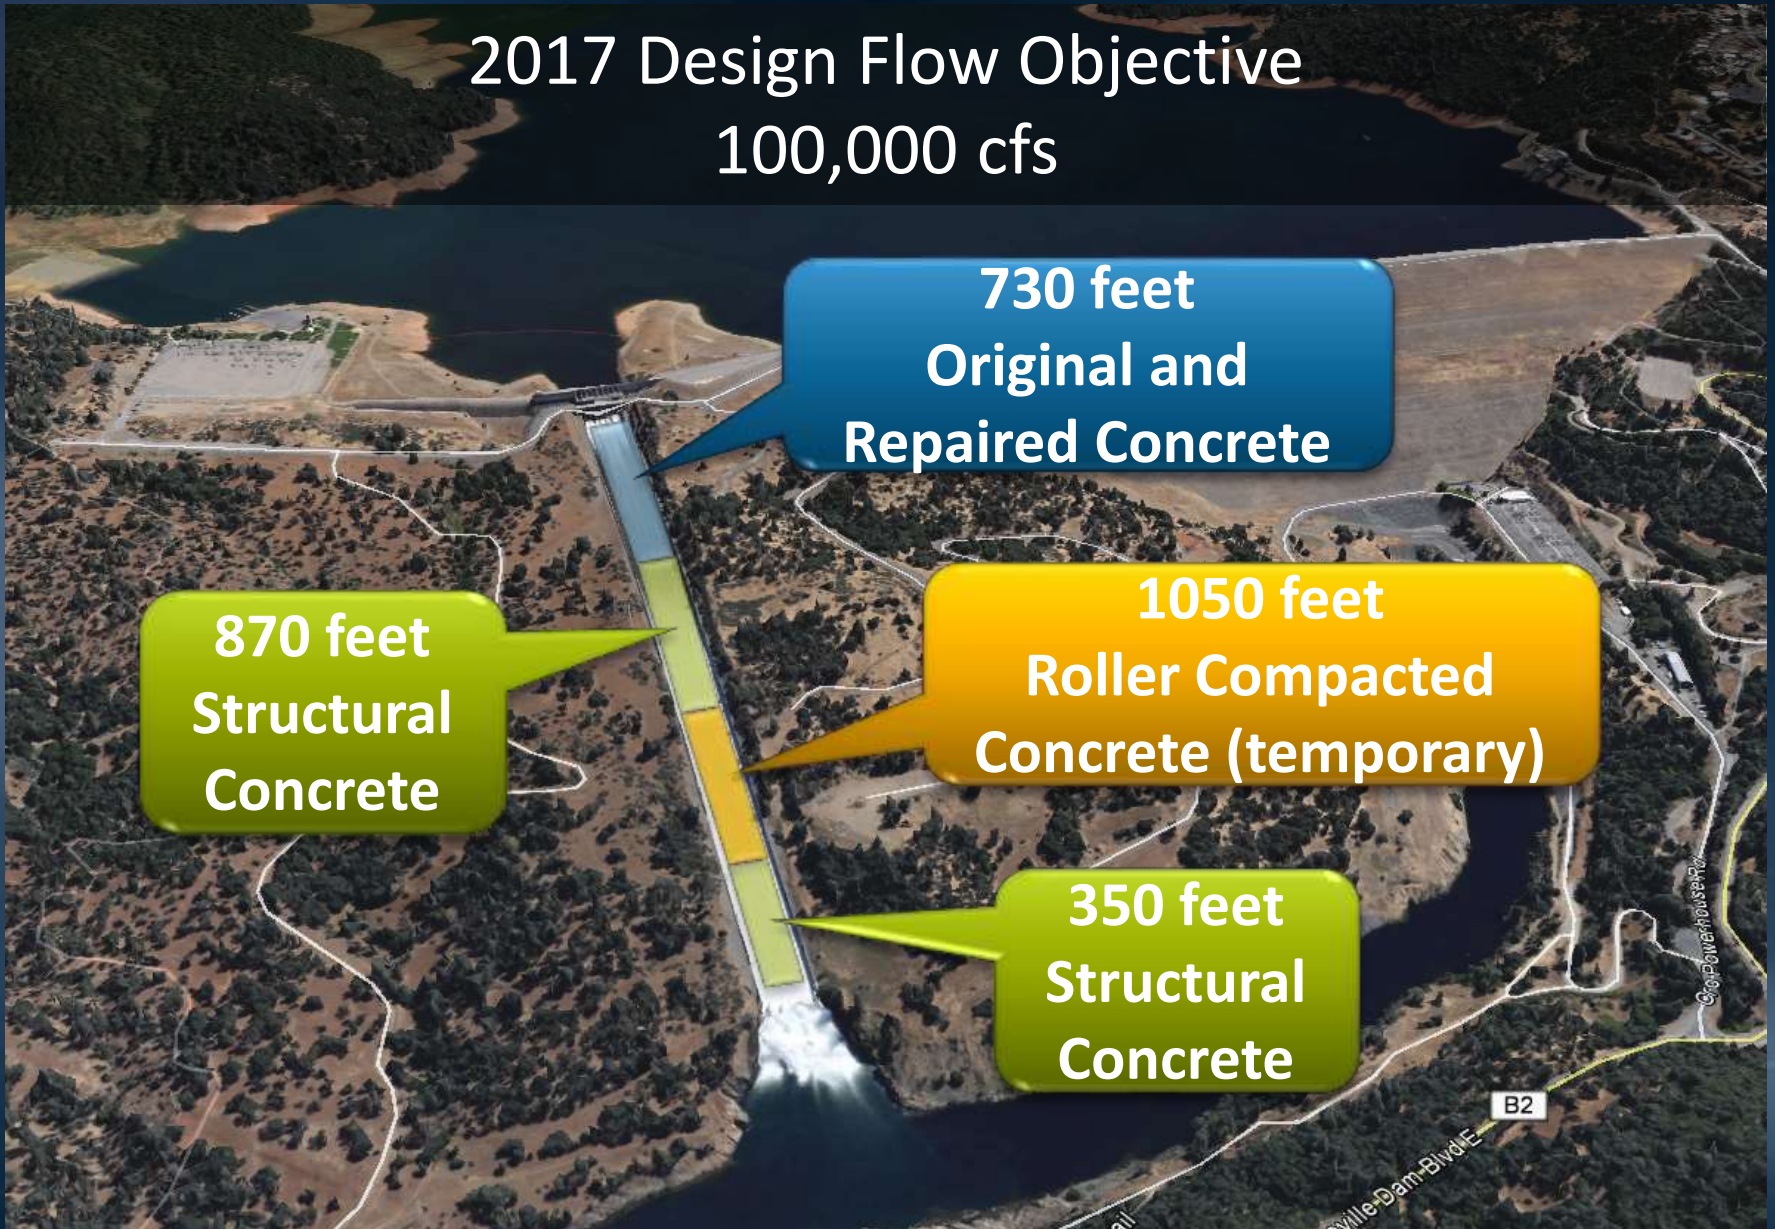
2017 Main Spillway Repair

2017 Design Flow Objective
100,000 cfs

730 feet
Original and
Repaired Concrete

870 feet
Structural
Concrete

1050 feet
Roller Compacted
Concrete (temporary)

350 feet
Structural
Concrete

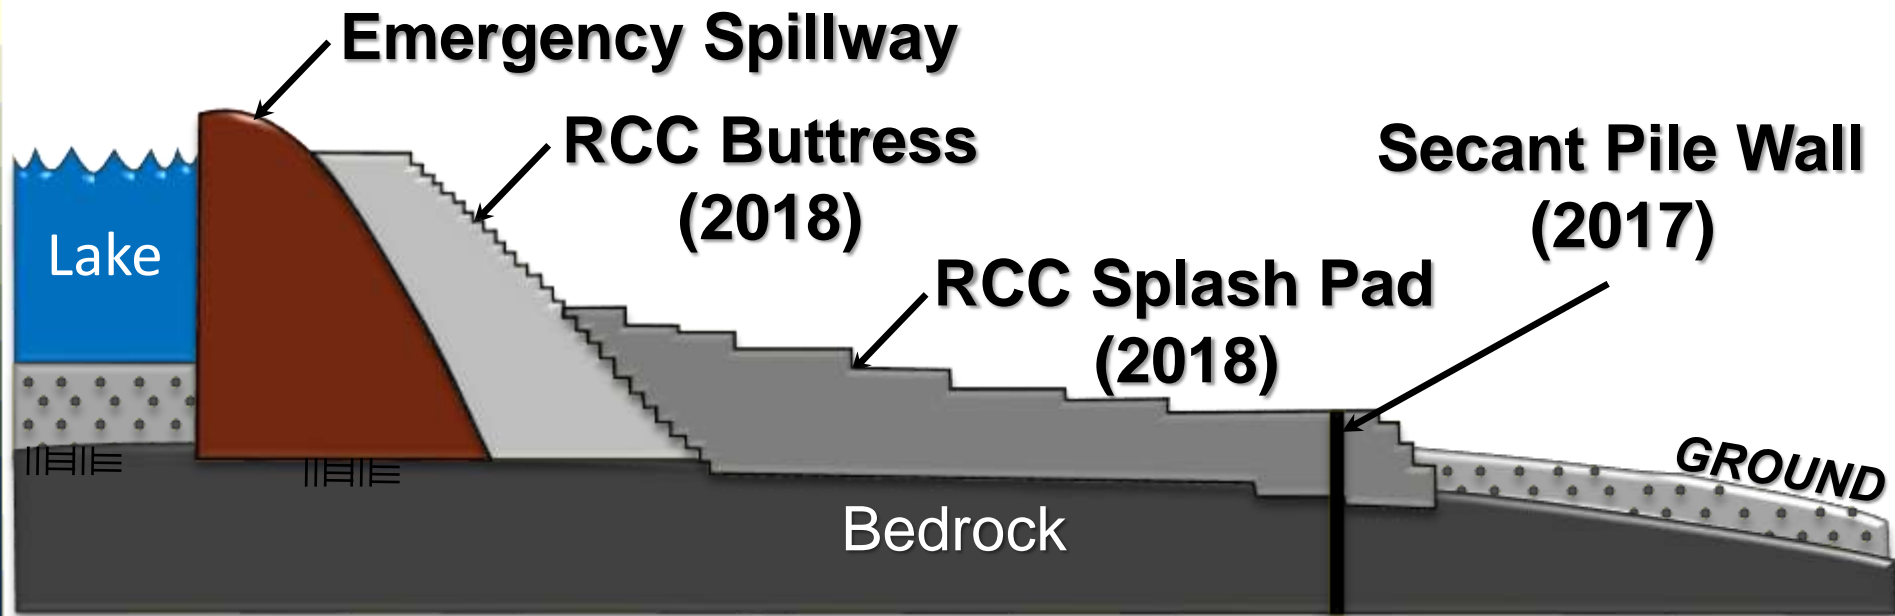
Emergency Spillway Repair Plan

- Designed to address erosion concerns
- Scheduled to be completed by late 2018
- Repairs will continue year-round until completed
