PCCP Rehabilitation & Replacement Program

Engineering & Operations Committee

Item 6a

June 10, 2013

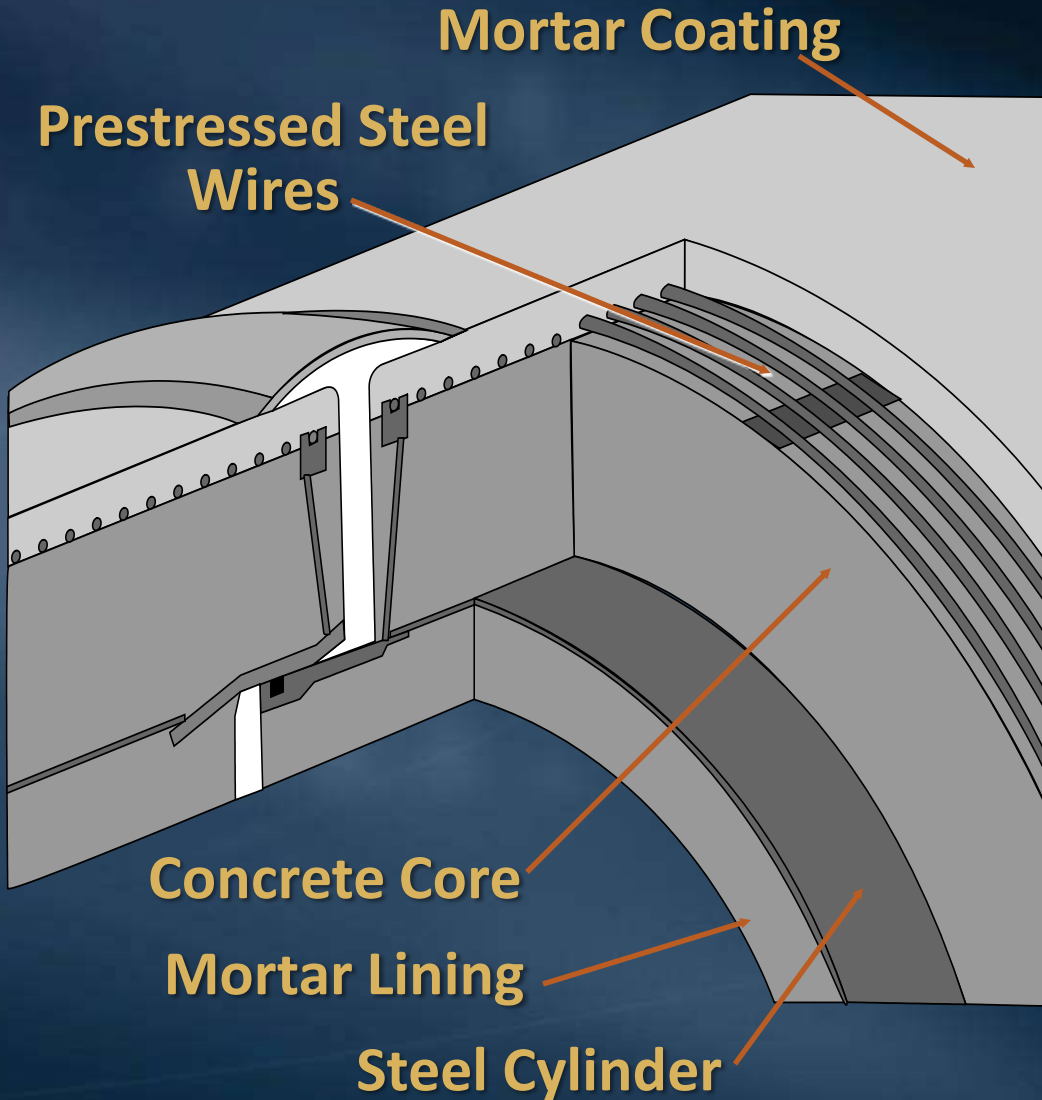
Prestressed Concrete Cylinder Pipe (PCCP)

Cross Section

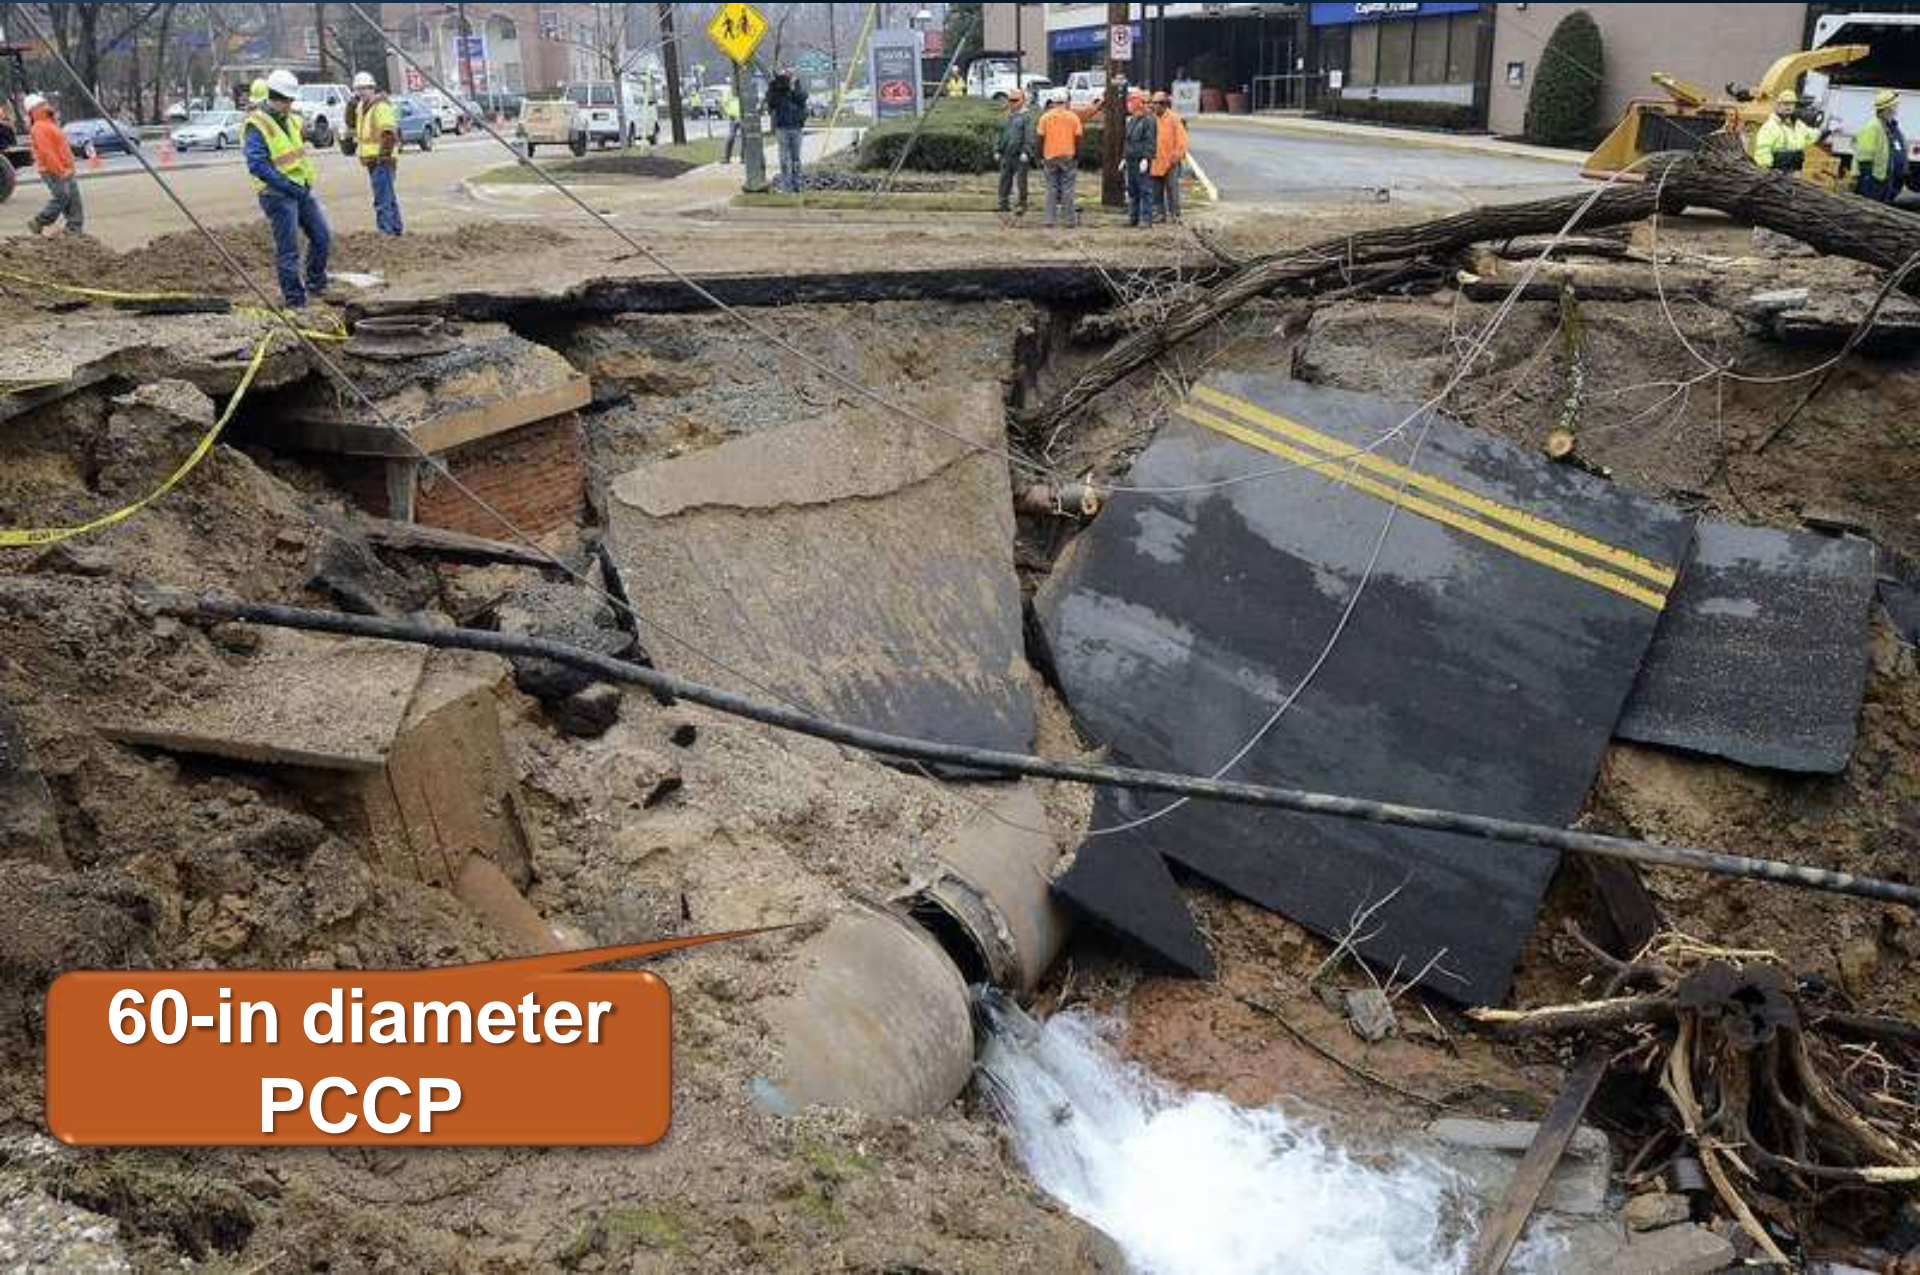
Maryland PCCP Wire Break

**60-in diameter
PCCP**

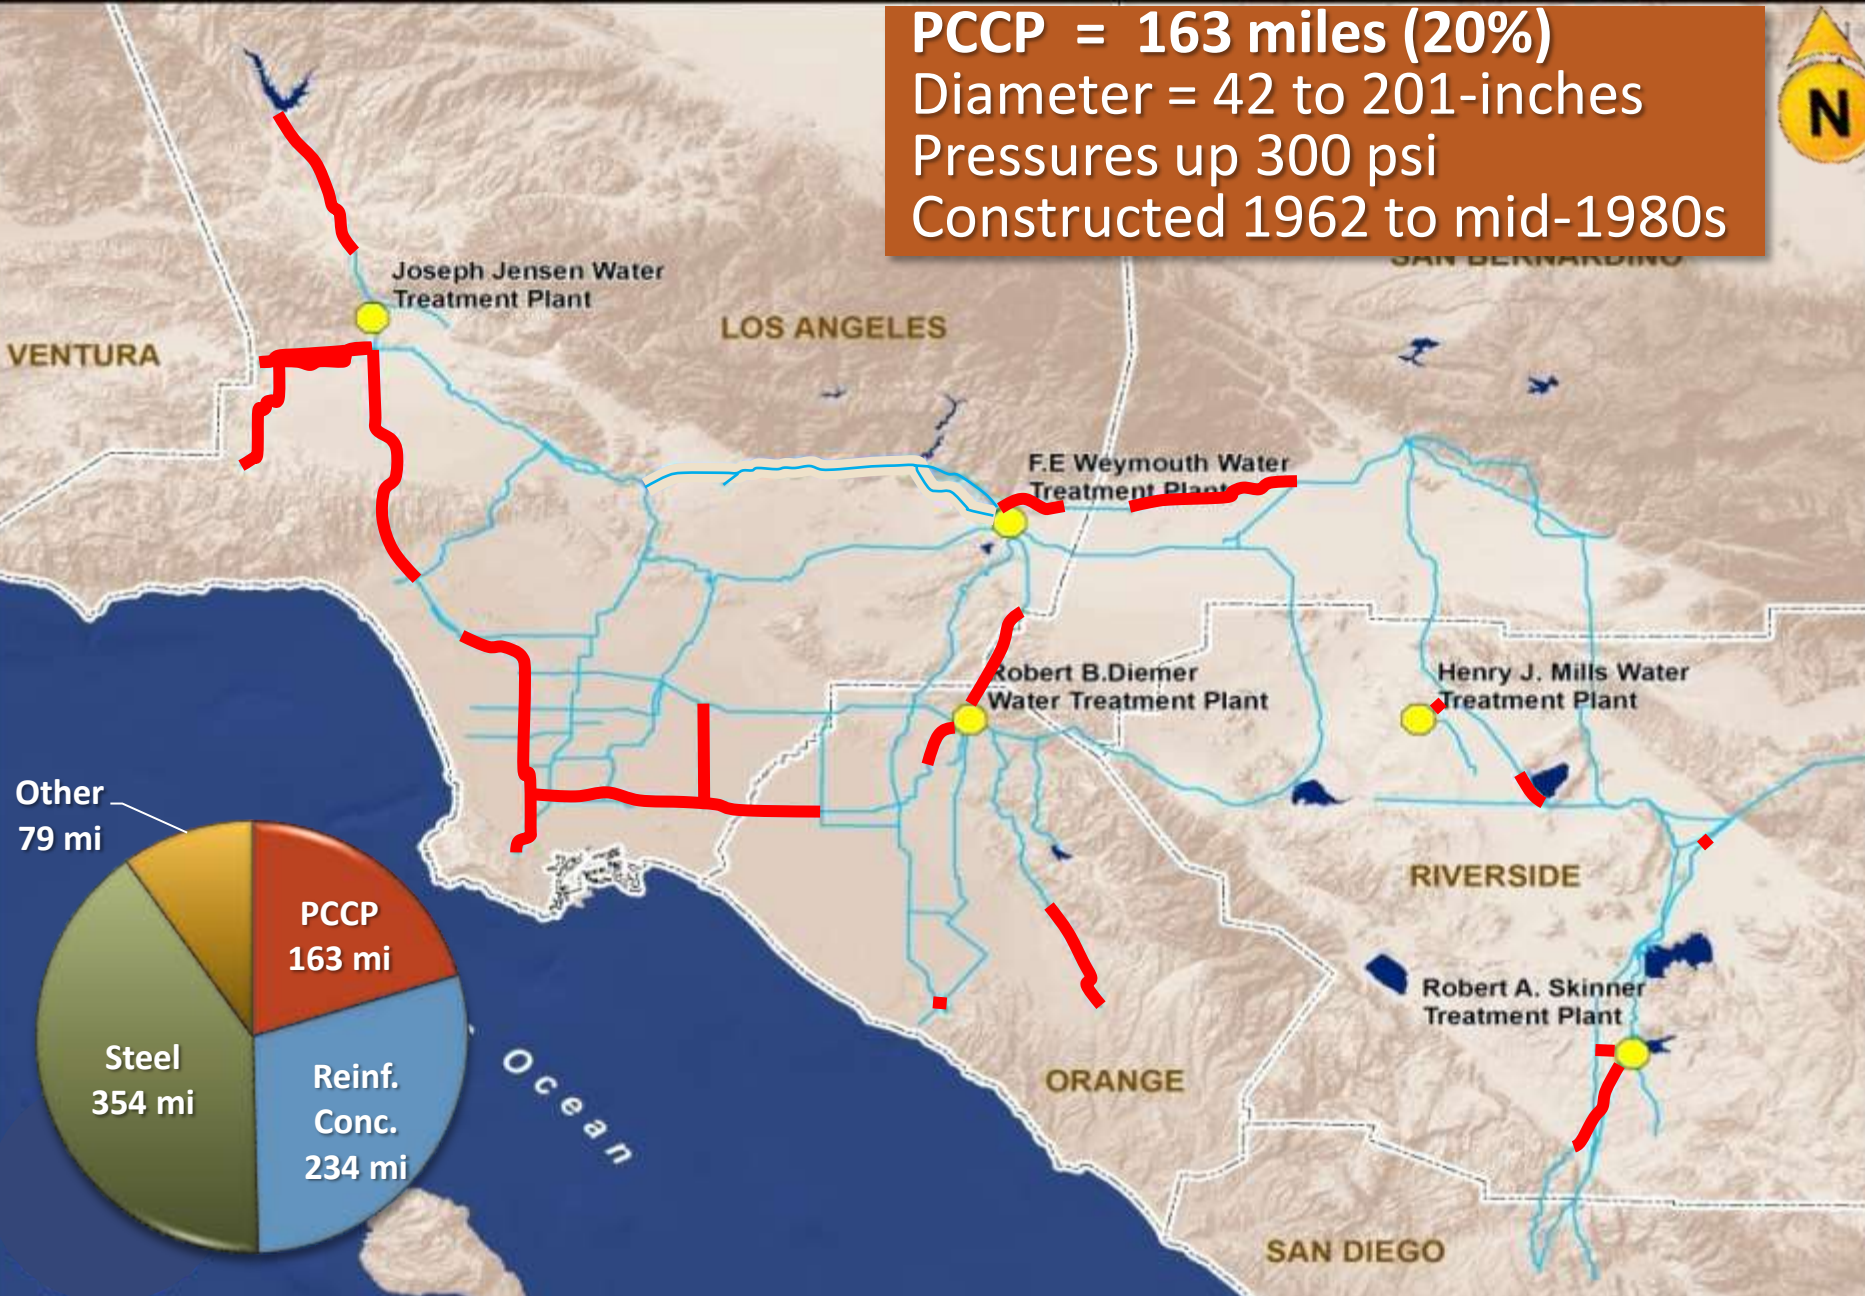
Metropolitan PCCP Lines

PCCP = 163 miles (20%)
Diameter = 42 to 201-inches
Pressures up to 300 psi
Constructed 1962 to mid-1980s
