Engineering Services Manager's Report

Engineering and Operations Committee
Item 7b

Strategy for Incorporating Seismic Resilience Into Capital Projects

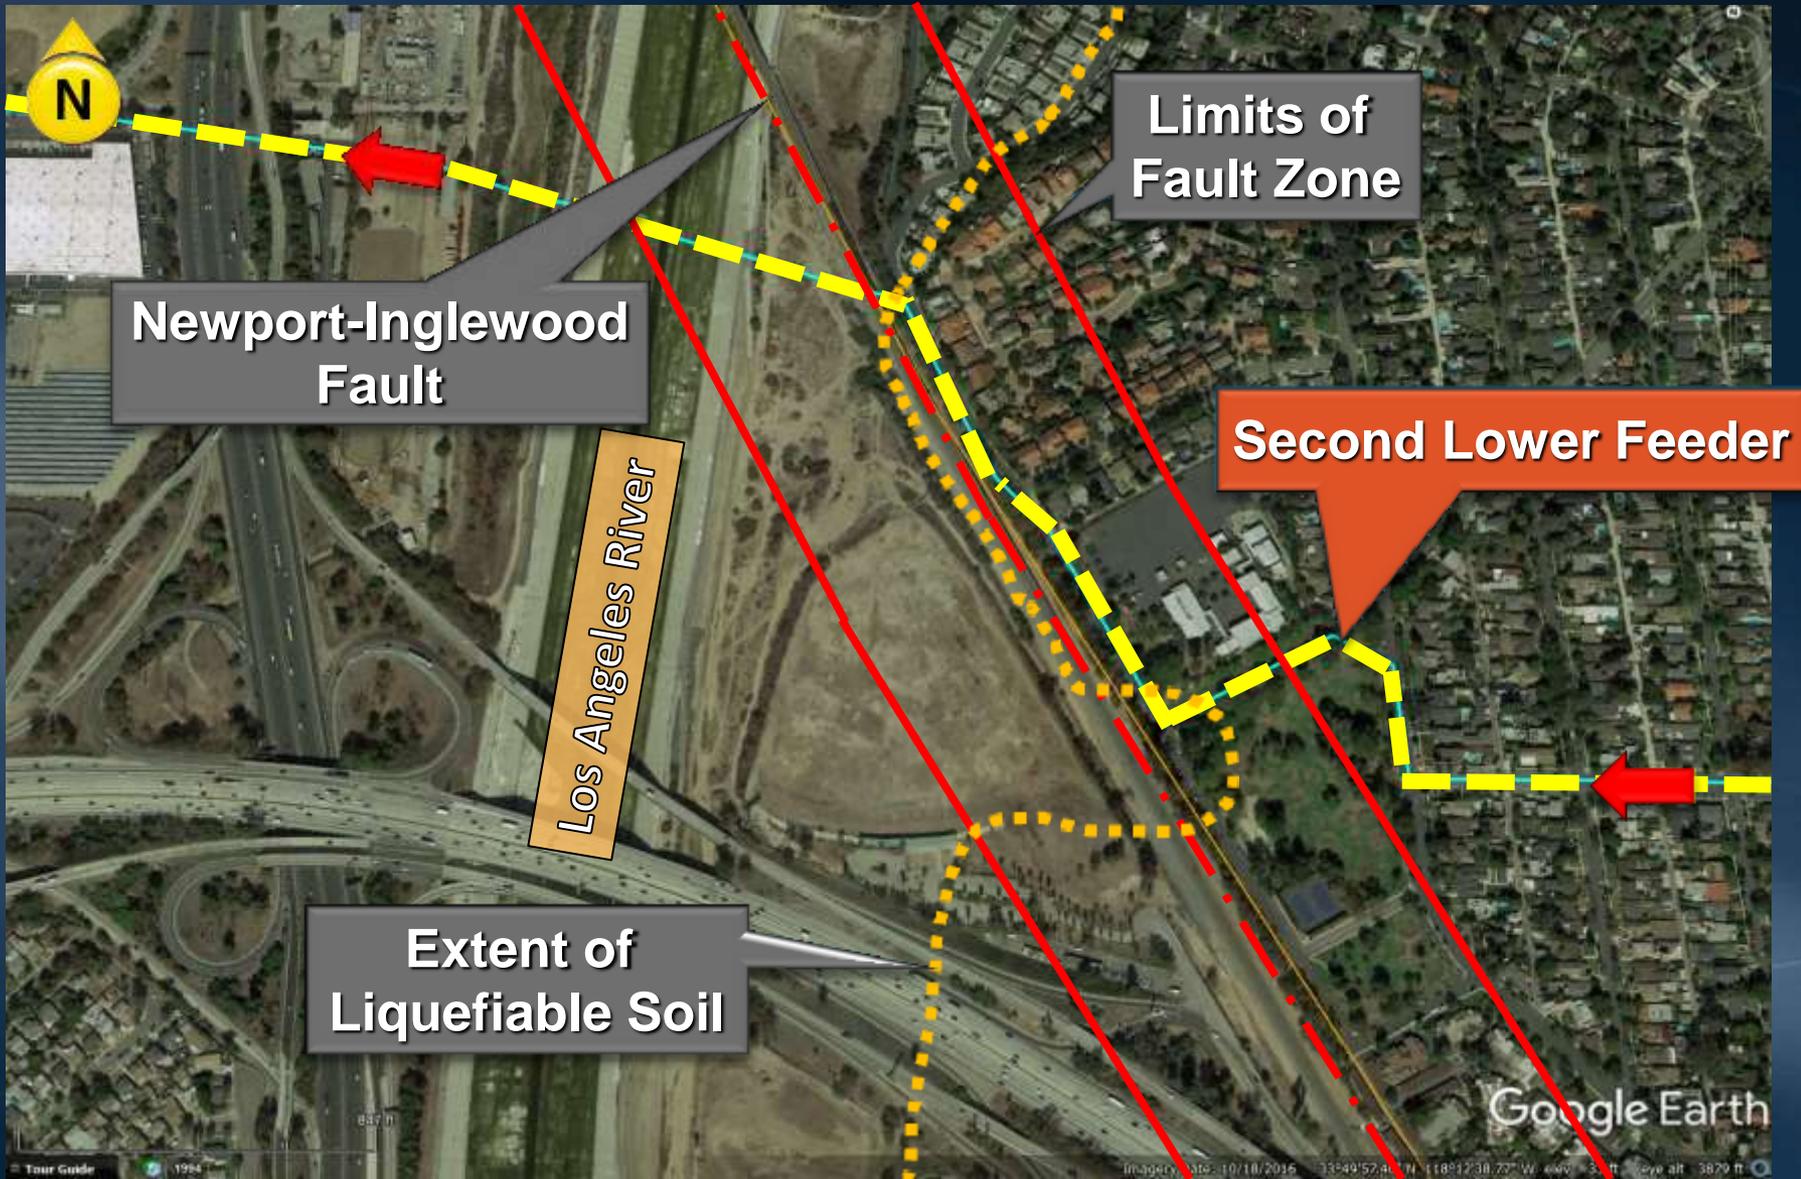
1. Second Lower Feeder

- Project underway to rehabilitate 28 miles of 78-inch dia. PCCP under multiple const. contracts
 - Majority of work includes lining PCCP with steel liner
 - Internal pressure is 300 psi
- Newport-Inglewood Fault
 - Capable of producing M7.5 earthquake
 - Potential horiz. displacement up to 16 ft at fault crossing, along with liquefaction
- Planned solution
 - Replace exist. line at fault crossing with earthquake-resistant steel pipe

Fault Crossing – Newport-Inglewood Fault

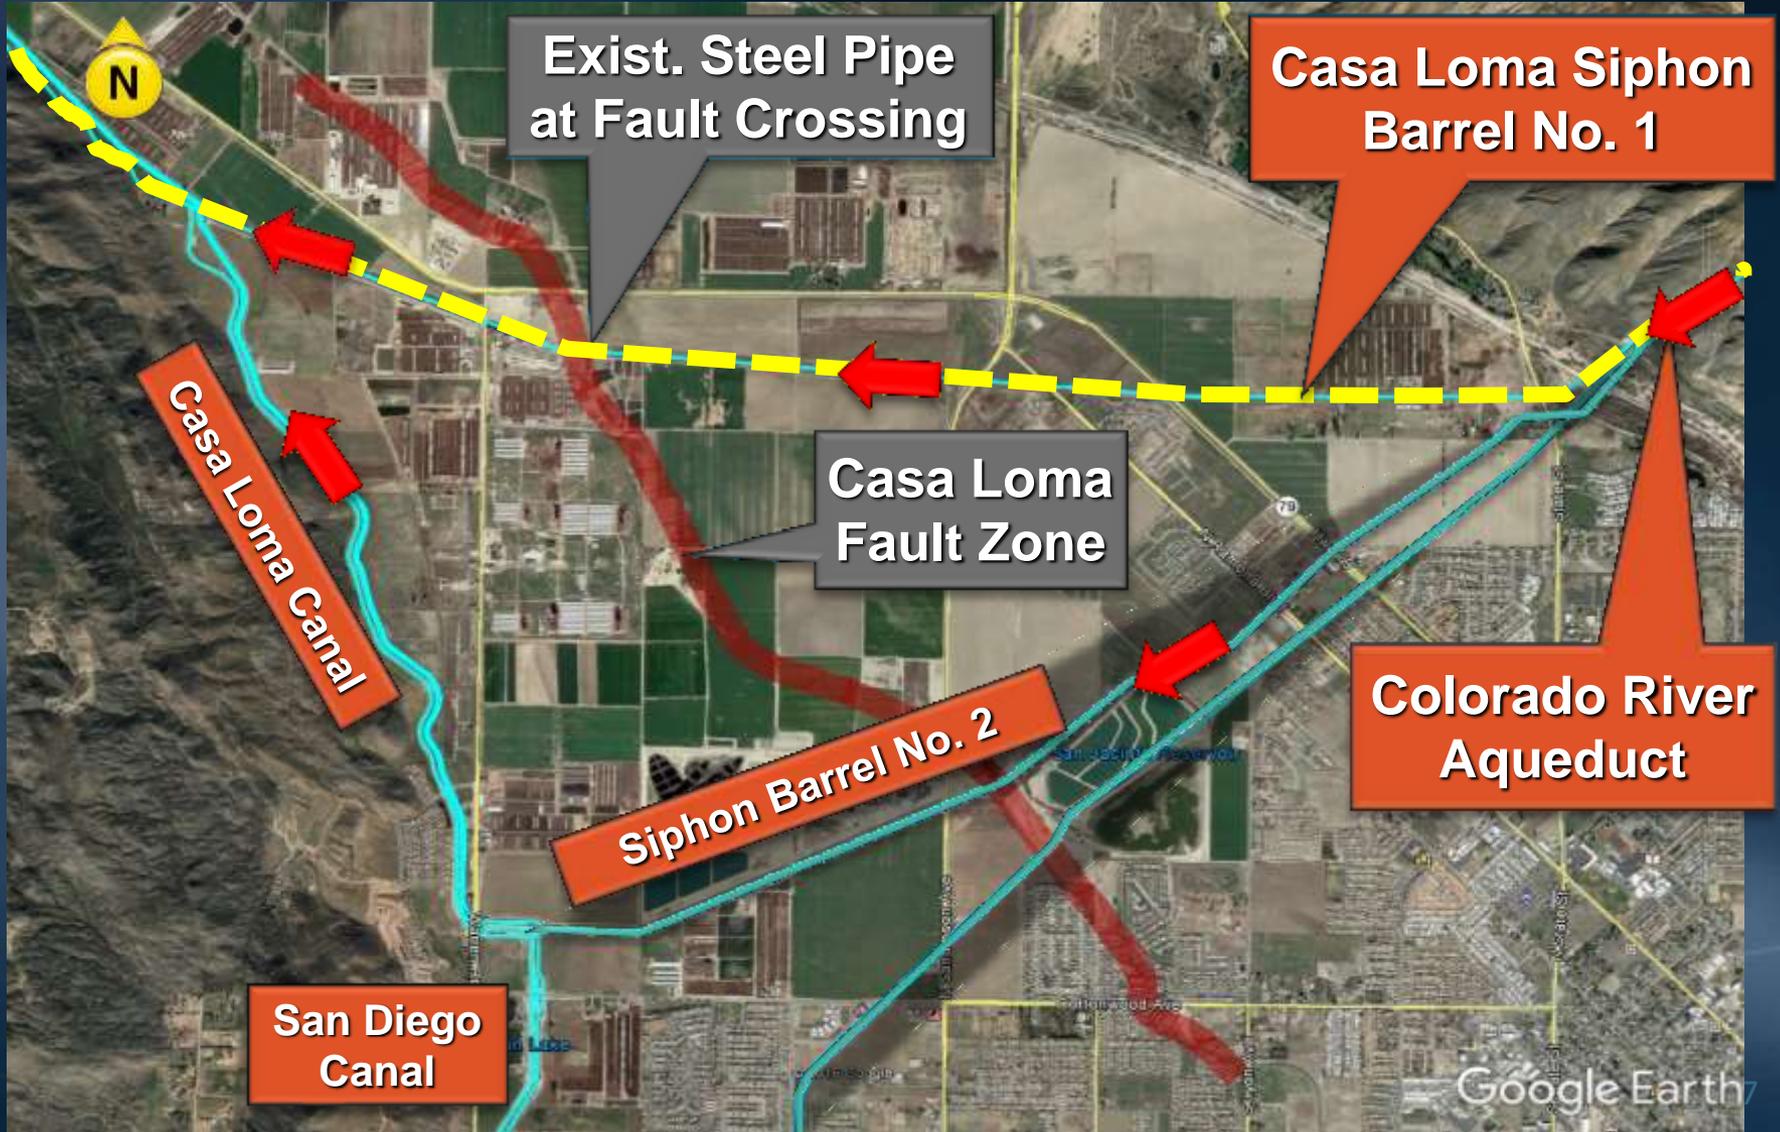
2. Casa Loma Siphon

- Project underway for permanent repairs to leaks on 150-inch dia. Casa Loma Siphon No.1 on the CRA
 - Regional subsidence has caused leaks for decades
 - Siphon No. 1 was originally concrete pipe, now steel pipe with external sleeve-type couplings on every joint
 - Couplings are corroded & continue to leak
 - Internal seals installed recently as interim measure
 - Internal pressure is 21 psi
- Casa Loma Fault (San Jacinto Fault System)
 - Capable of producing M6.7 earthquake
 - Potential displacement of 1 ft if fault ruptures on its own, or 10 ft if multiple reaches rupture
- Planned solution
 - Replace exist. line at fault crossing with earthquake-resistant ductile iron pipe

Fault Crossing – Casa Loma Fault (San Jacinto Fault System)
